# Is Empshott Grange a *safe* school location?

*An evidence-based review of traffic, carriageway geometry and network resilience on the B3006, Mill Lane and Church Lane.*

Proposed school development at  
Empshott Grange

Highway safety & network resilience

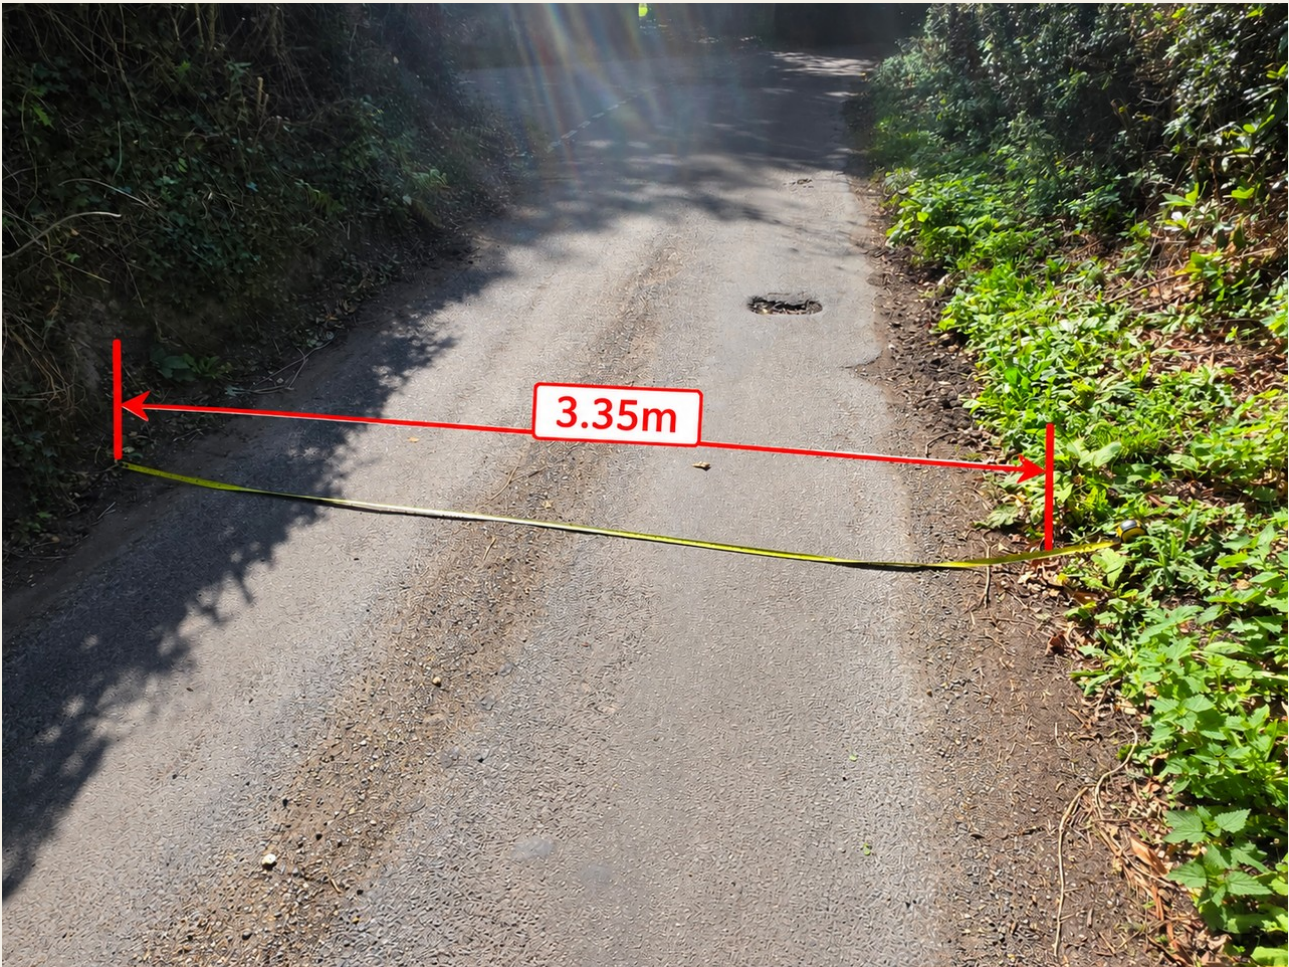
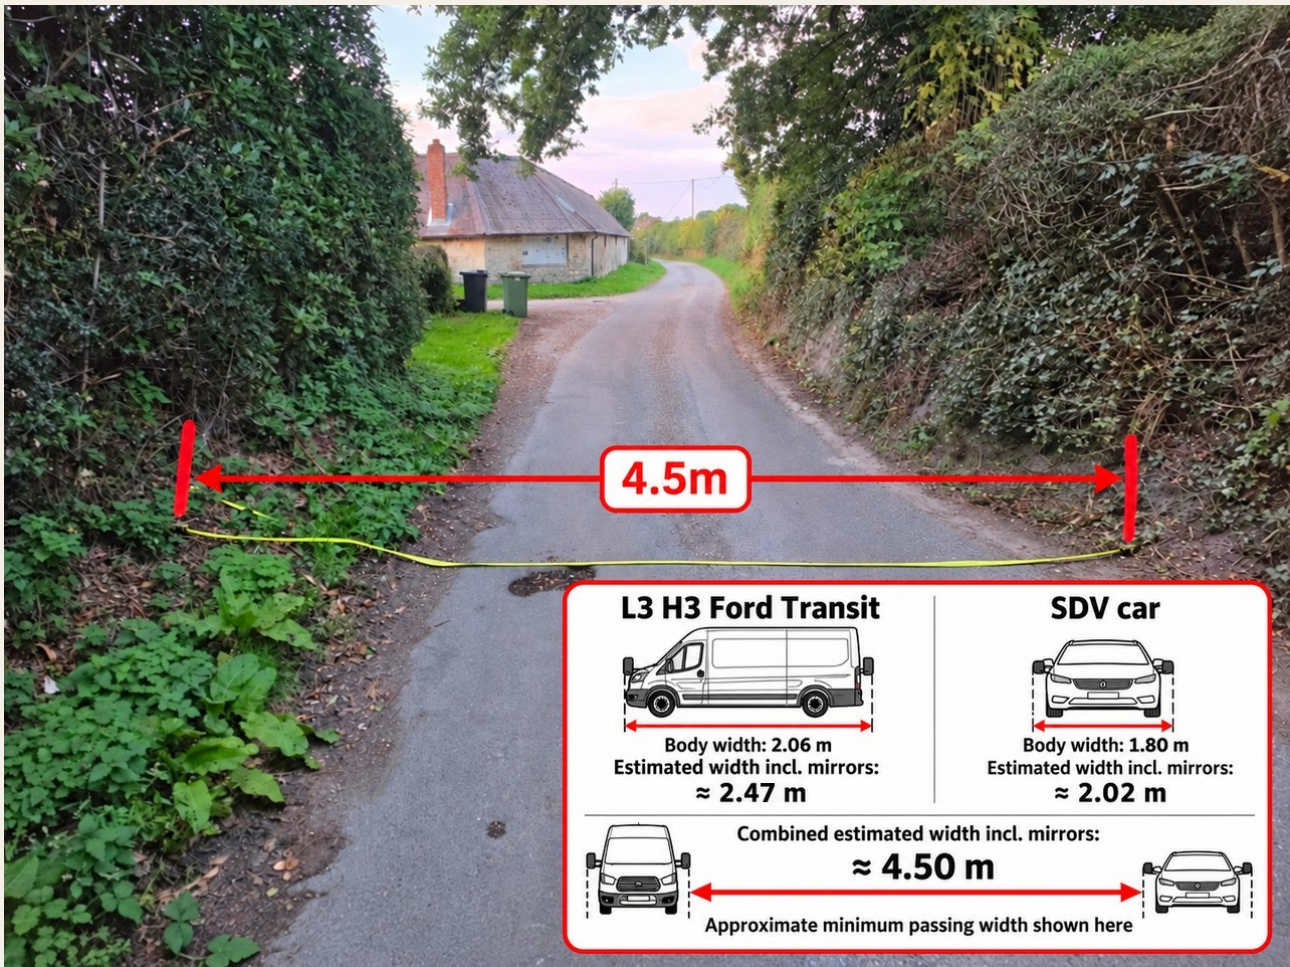
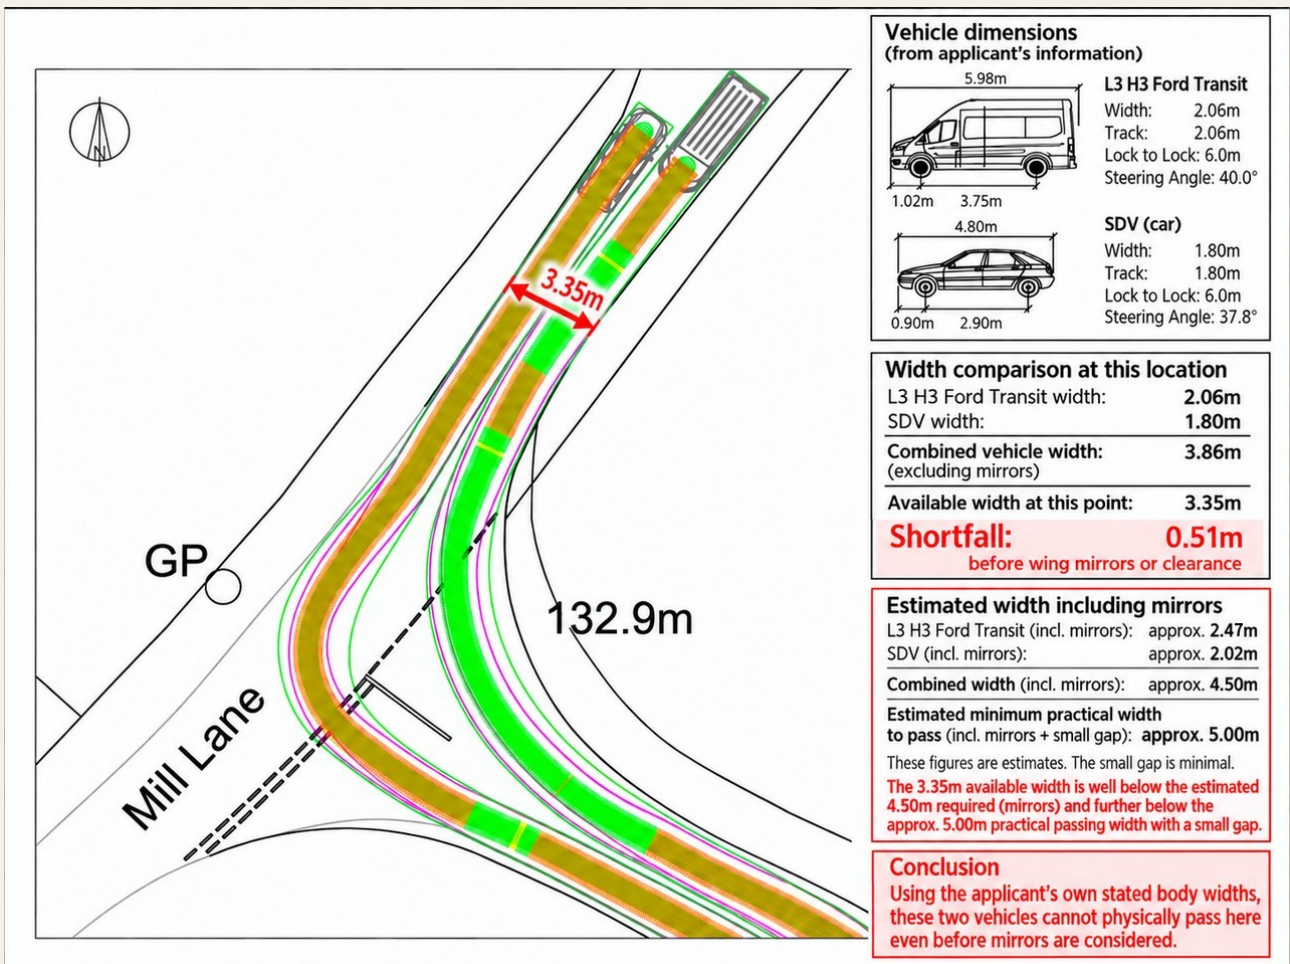
## **Applicant's swept-path analysis depicts simultaneous passing at a 3.35 m pinch point**

The photographs above record the measured carriageway width of approximately 3.35 m at this point on Mill Lane, alongside the roughly 4.5 m that two vehicles would actually need to pass. This is the same point through which the applicant's swept-path analysis depicts two opposing vehicle movements.

The applicant's own stated vehicle widths are 2.06 m for the L3 H3 Ford Transit and 1.80 m for the SDV, giving a combined body width of 3.86 m, excluding mirrors (Additional Highways Plans, SDNP/25/03084/FUL).

The combined stated body width therefore exceeds the measured carriageway width by approximately 0.51 m before any allowance is made for wing mirrors, clearance between the vehicles, or clearance from the edges of the carriageway. In practical terms, the discrepancy would be greater once mirrors and even a minimal passing gap were taken into account.

This raises an important question as to how the simultaneous swept paths shown on drawing TR/06 can be reconciled with the physical dimensions of the highway at this location.

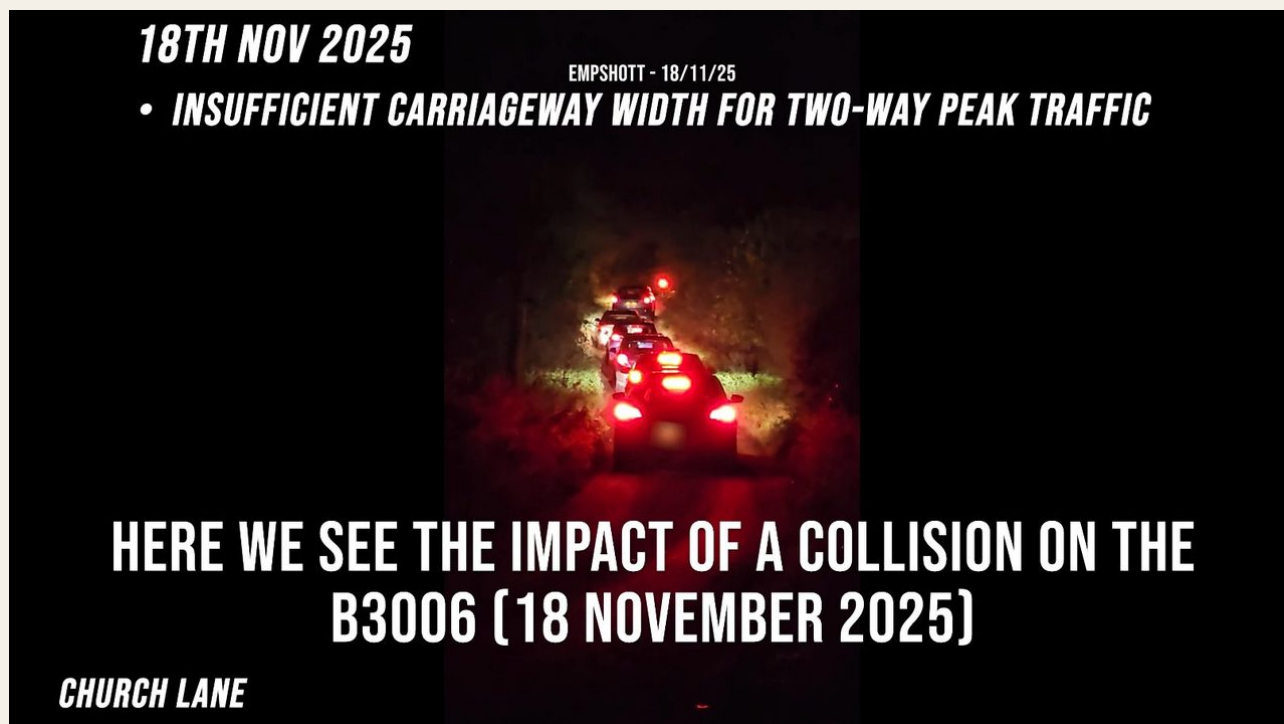
**B3006 · 18 NOVEMBER 2025**

## The school is likely to be inaccessible several times a year

On the evening of 18 November 2025 a collision on the B3006 caused queues to back up into the adjoining lanes, and traffic across Empshott — Mill Lane and Church Lane included — ground to a halt. With no viable alternative route, a single incident on the main road renders the surrounding network effectively impassable. In those conditions access for emergency vehicles would be severely constrained. Incidents like this occur several times a year, and when they do, parents and children may be unable either to reach the school or to leave it. This is the network into which school-generated traffic would be added.

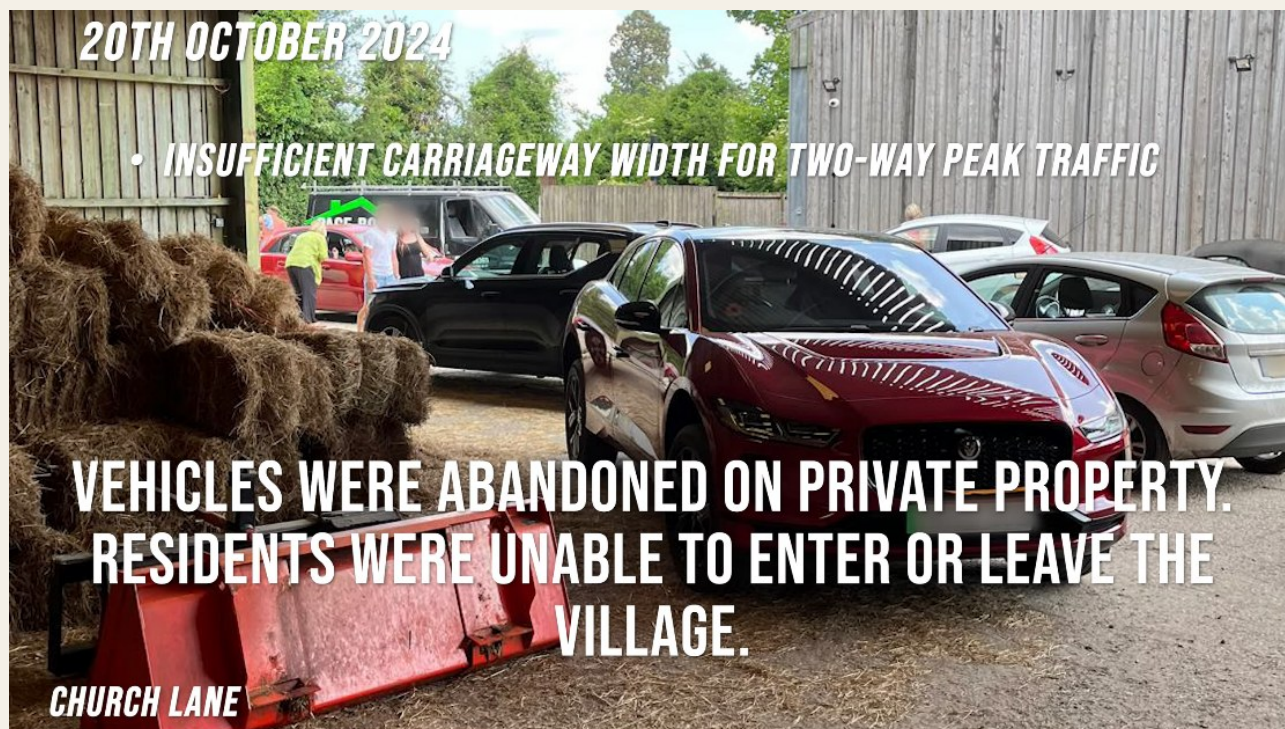
CHURCH LANE · 20 OCTOBER 2024

## A crash on the B3006 blocks the village

On 20 October 2024, a crash on the B3006 sent traffic onto Church Lane. With nowhere to pass or turn, drivers abandoned their vehicles on private property, and residents were unable to enter or leave the village. The same pattern was recorded again on 3 February 2026: when the main road is blocked, the village is cut off.

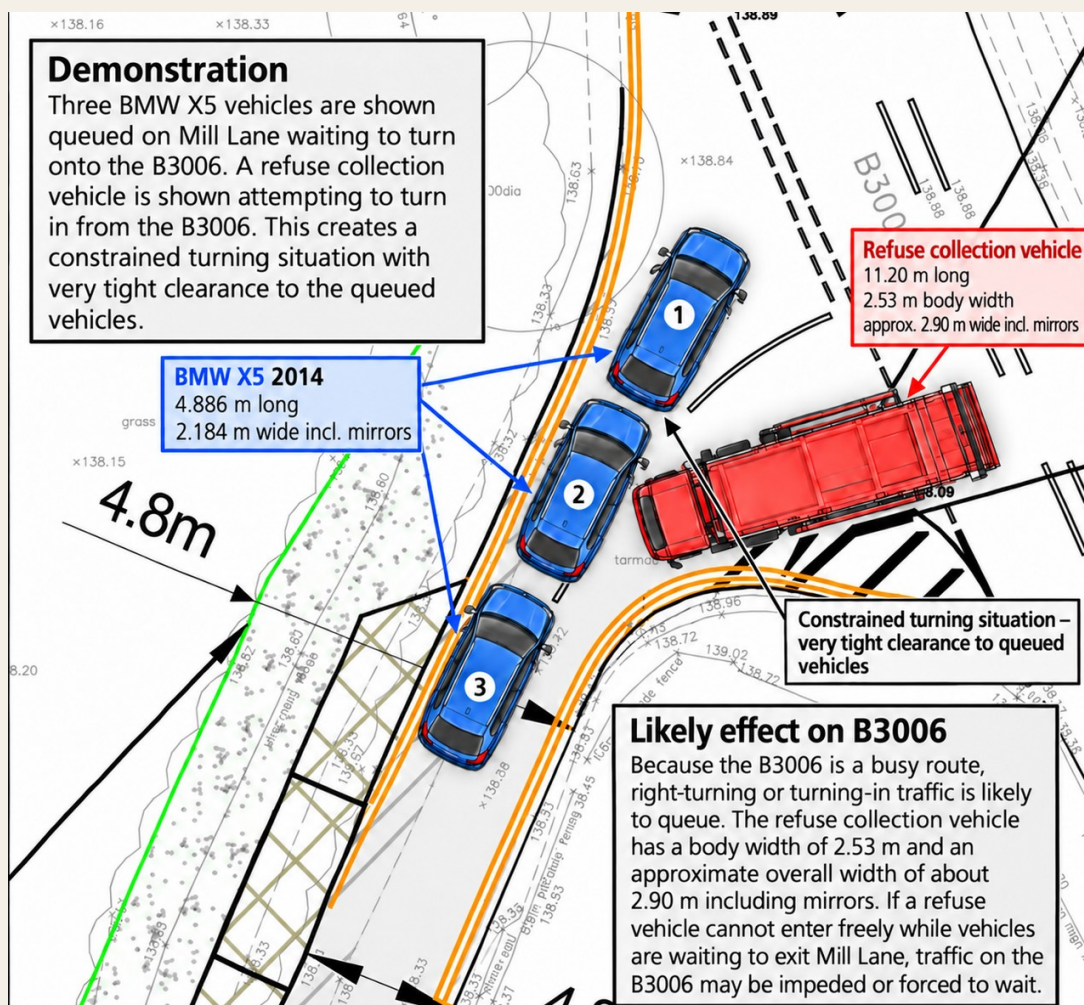
## MILL LANE / B3006 JUNCTION · CARRIAGEWAY WIDTH 4.8 M

## At the proposed 4.8 m width, large vehicles may still be unable to pass safely at the angled junction

A 2014 BMW X5 is approximately 1.938 m wide excluding mirrors, while the applicant's refuse vehicle is stated as 2.53 m wide. On those body-width dimensions alone, the two vehicles would occupy 4.468 m of the proposed 4.8 m carriageway, leaving only 0.33 m of theoretical total remaining width — before allowing for mirrors or any practical driving clearance.

Including mirrors, the margin becomes smaller still. The X5 is approximately 2.184 m mirror-to-mirror. If the refuse vehicle's actual mirror-to-mirror width is approximately 2.9 m, their combined width would be about 5.084 m, exceeding the proposed carriageway width by approximately 0.28 m.

The proposed widening to 4.8 m is intended to improve two-way movement at the junction. However, Hampshire County Council Highways itself acknowledges that with larger vehicles there are circumstances where passing a car is unachievable within the highway constraints.

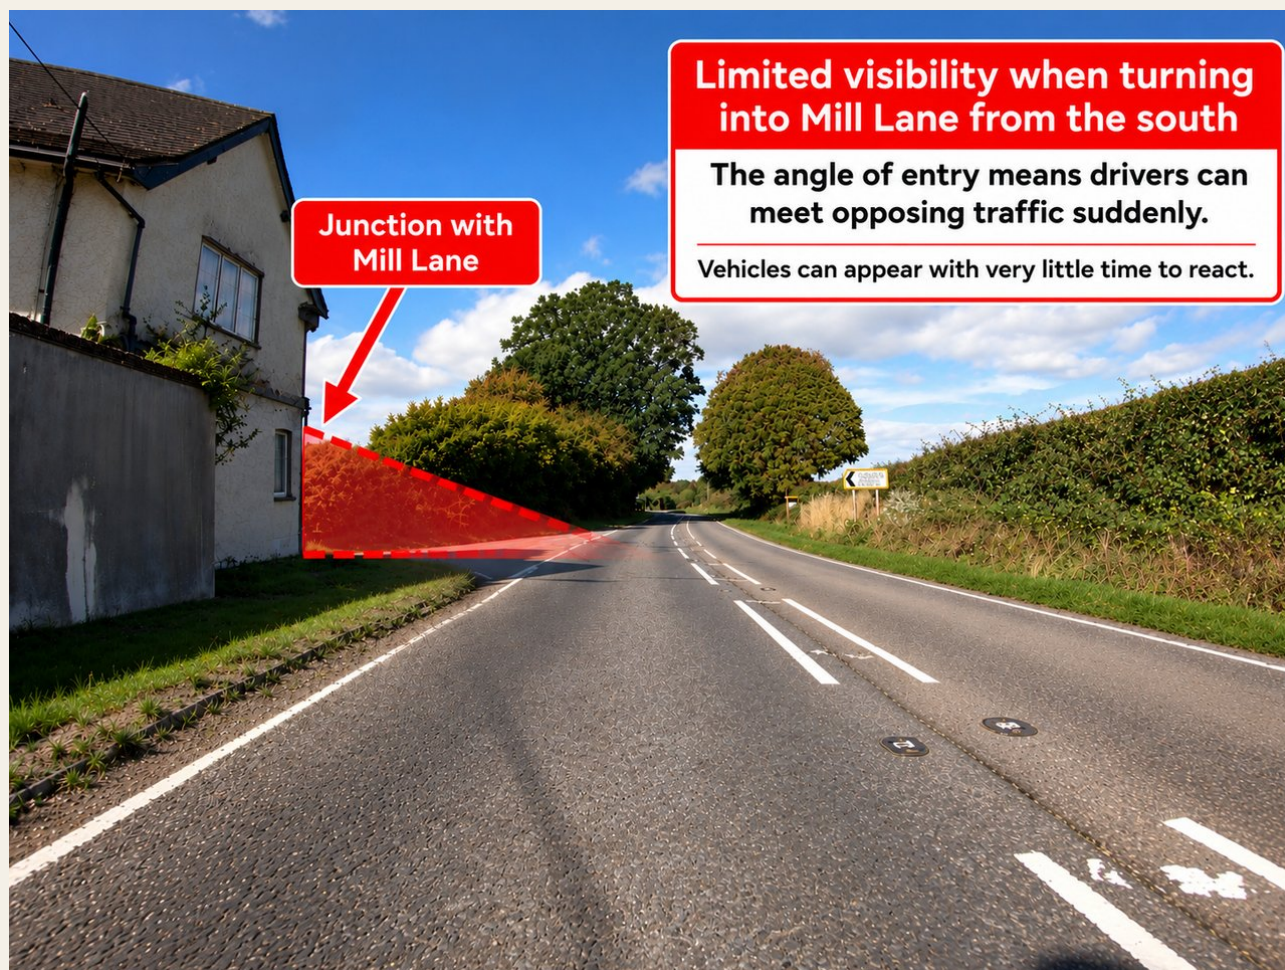
**B3006 · APPROACHING THE MILL LANE JUNCTION**

## **Limited visibility approaching the Mill Lane junction**

Approaching the Mill Lane junction from the south, visibility is effectively blind until the last moment. Even with the proposed widening, drivers may have very little time to see and react to vehicles entering or leaving the junction.

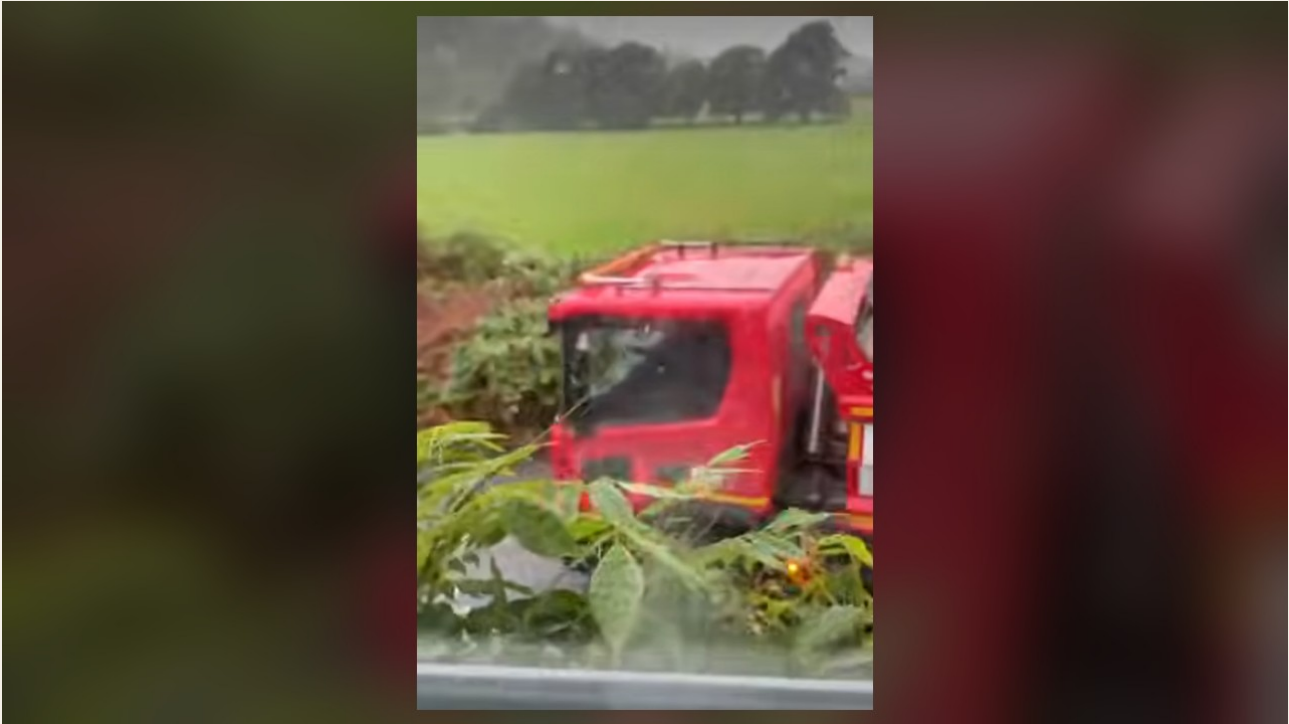
MILL LANE / B3006 JUNCTION · SEPTEMBER 2026

## HGVs must turn several times just to enter Mill Lane

Filmed in September 2026, this clip shows a heavy goods vehicle turning off the B3006 into Mill Lane. The junction is so tight that the HGV cannot complete the turn in one movement — it has to shunt back and forth, making several turns to line itself up with the lane, holding up traffic on the B3006 as it does so.

The proposed widening of the junction would help with this — but only when the lane is clear. With vehicles queued on Mill Lane waiting to exit, as they would be at a school's peak times, the room to complete the turn is lost and the obstruction returns.

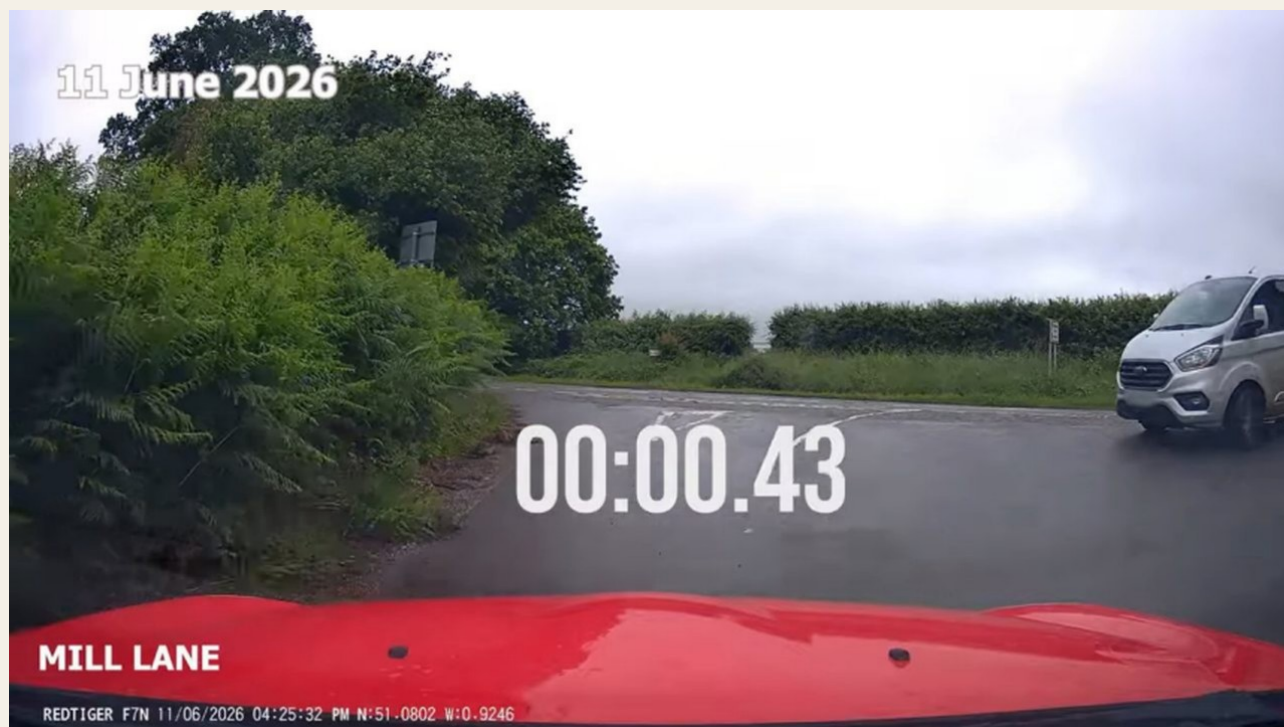
MILL LANE / B3006 JUNCTION · 11 JUNE 2026

## Limited warning and minimal passing clearance at the widened B3006 junction

This clip illustrates the limited warning available to a vehicle waiting to leave Mill Lane when another vehicle turns in from the B3006. Although the proposal widens the approach to 4.8 metres, widening the carriageway does not remove the underlying conflict at the junction.

A vehicle approaching from the south on the B3006 can begin turning into Mill Lane before it becomes clearly visible to traffic waiting to emerge. In the filmed example, the interval from first sight of the approaching van to the potential conflict point is approximately 0.75 seconds.

The available passing margin is also very small. A 2014 BMW X5 is approximately 2.184 m wide including mirrors. Two X5s travelling in opposite directions would therefore occupy 4.368 m of a 4.8 m carriageway, leaving only 0.43 m of theoretical total clearance — around 0.22 m per vehicle if both were perfectly positioned.

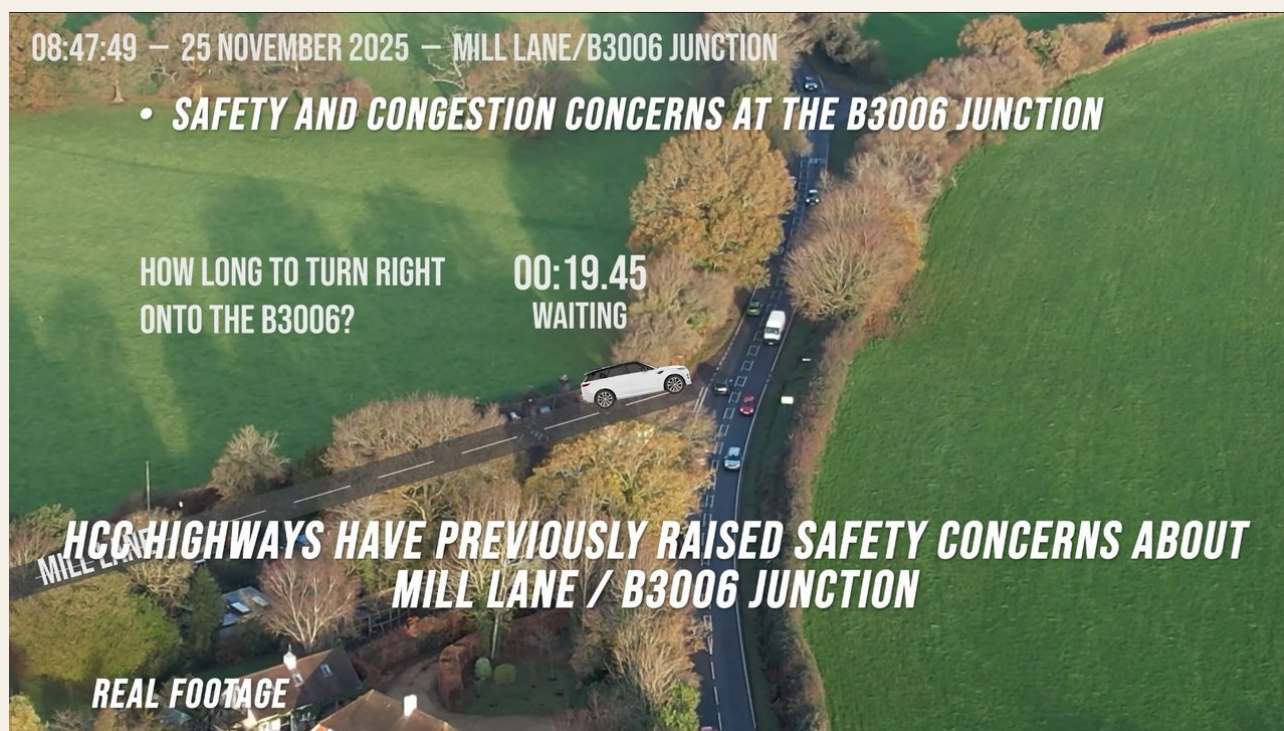
MILL LANE / B3006 JUNCTION · 25 NOVEMBER 2025

## Long waits and queueing remain despite the widening

Widening the first approximately 60 metres of Mill Lane does nothing to reduce the time vehicles must wait for a safe gap in fast-moving B3006 traffic. In the footage — real traffic on the B3006 — the superimposed vehicle would have had to wait around two minutes for a safe gap to turn right. As vehicles accumulate, the queue simply extends back along the widened section until it reaches the point where Mill Lane narrows again to single track.

Using a 2014 BMW X5 as a reference vehicle at 4.886 m long, and allowing roughly 1 metre between cars, only about 10 vehicles would fit within a 60 m section before the queue reached the single-track lane. At that point, vehicles trying to travel in the opposite direction would meet a stationary queue with nowhere to pass except the existing passing places, creating the potential for severe obstruction or gridlock.

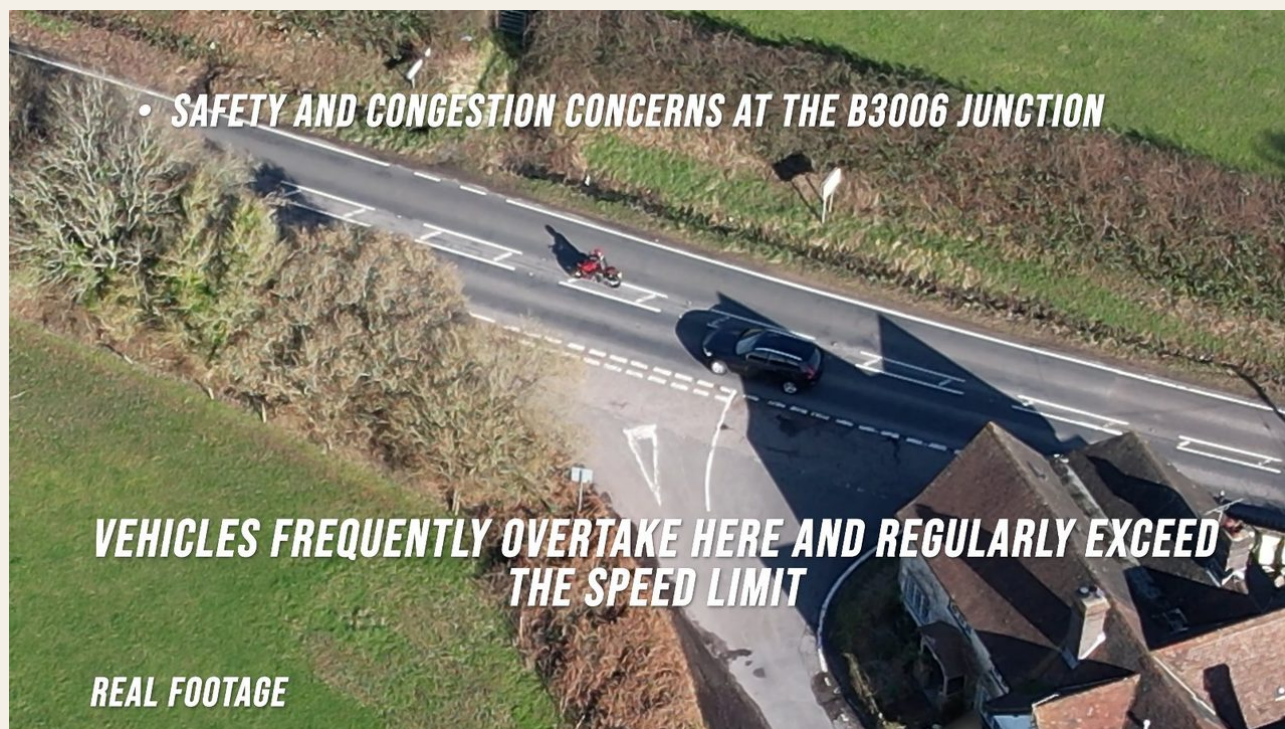
B3006, MILL LANE JUNCTION · REAL FOOTAGE

## Overtaking and excess speed at the junction

On the B3006 approach to the Mill Lane junction, vehicles frequently overtake and regularly exceed the speed limit, with local residents reporting speeds well above it. They accelerate hard in anticipation of the national speed limit on the unrestricted road just beyond the junction — so traffic is gathering speed at exactly the point where turning vehicles must pull out. A new junction generating regular turning movements — parents unfamiliar with the road, slow-moving coaches — would introduce repeated conflict with that fast through-traffic. Under pressure from fast approaching vehicles and mounting delay, drivers waiting to turn are drawn into poor gap acceptance — accepting marginal gaps and making risky decisions — and at these speeds there is little margin for error. By any reasonable measure, it is a dangerous junction.

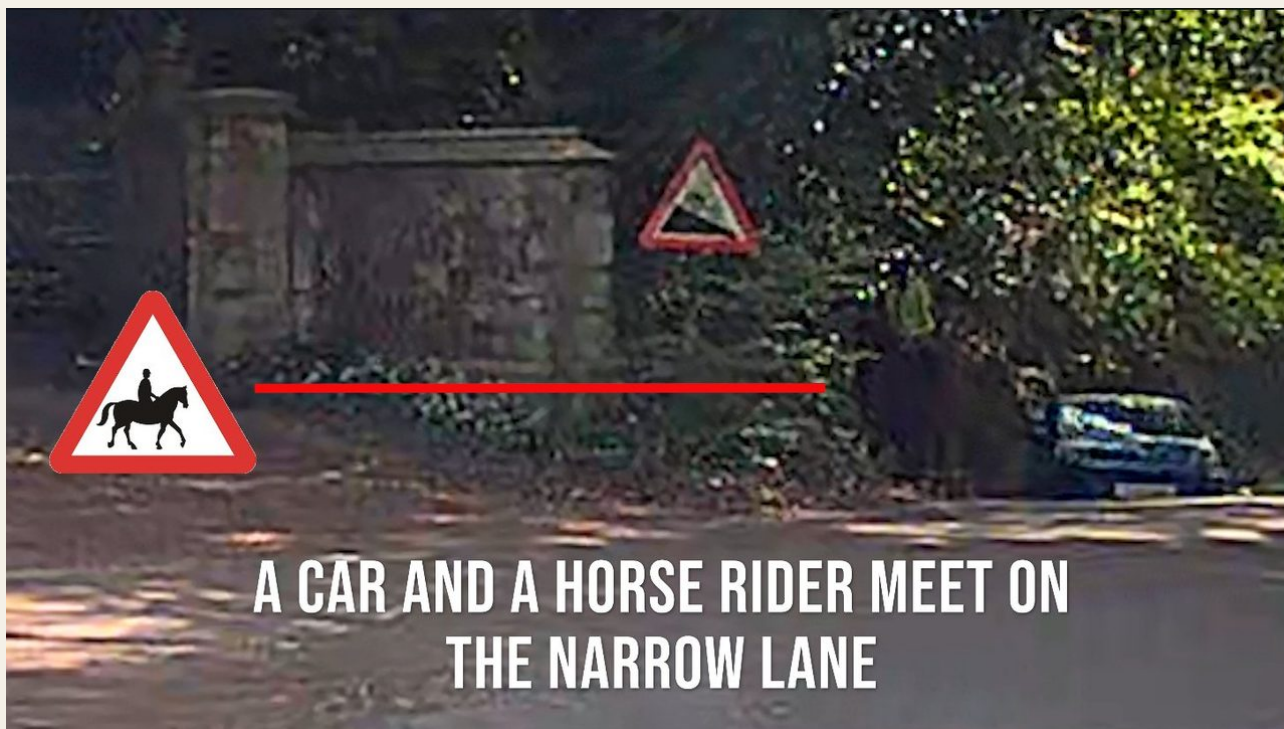
MILL LANE / CHURCH LANE · 8 MAY 2026

## A CAR AND A HORSE RIDER MEET ON THE NARROW LANE

### Vulnerable road users have no safe refuge

The footage demonstrates the problem directly: the approaching car has to stop because there is insufficient room to pass the horse safely. Neither the horse and rider nor the vehicle has a proper refuge; beyond occasional gateways or passing places, the alternatives are essentially the verge, hedge or carriageway itself. This creates an inherently constrained and potentially hazardous situation.

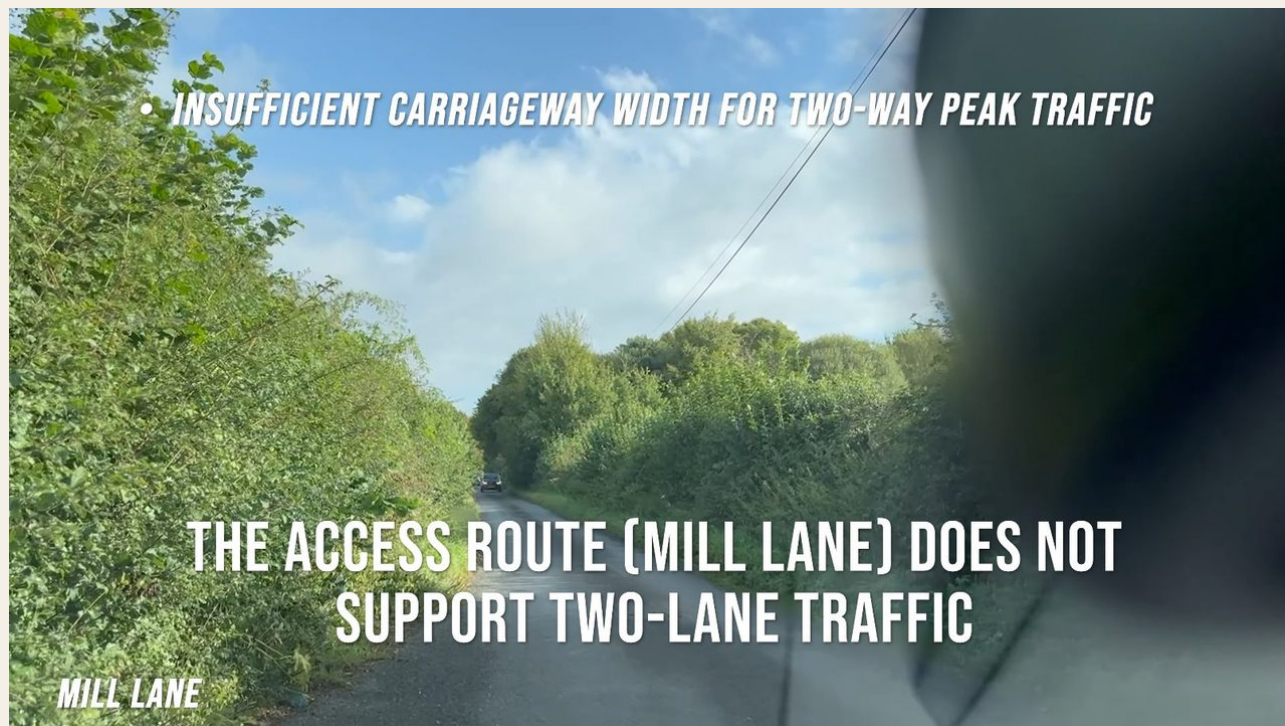
## MILL LANE • INSUFFICIENT CARRIAGEWAY WIDTH

### The access route cannot carry two-way traffic

Mill Lane — the principal access route to the site — does not support two-lane traffic. A single-track lane, it has insufficient width for two vehicles to pass at peak demand; where vehicles meet, one must yield to the verge or reverse to a wider point. The footage shows that even minor increases in traffic cause immediate congestion, and that multiple vehicles arriving simultaneously cause obstruction. Concentrated school-hour movements would force this repeatedly, at the busiest times of day.

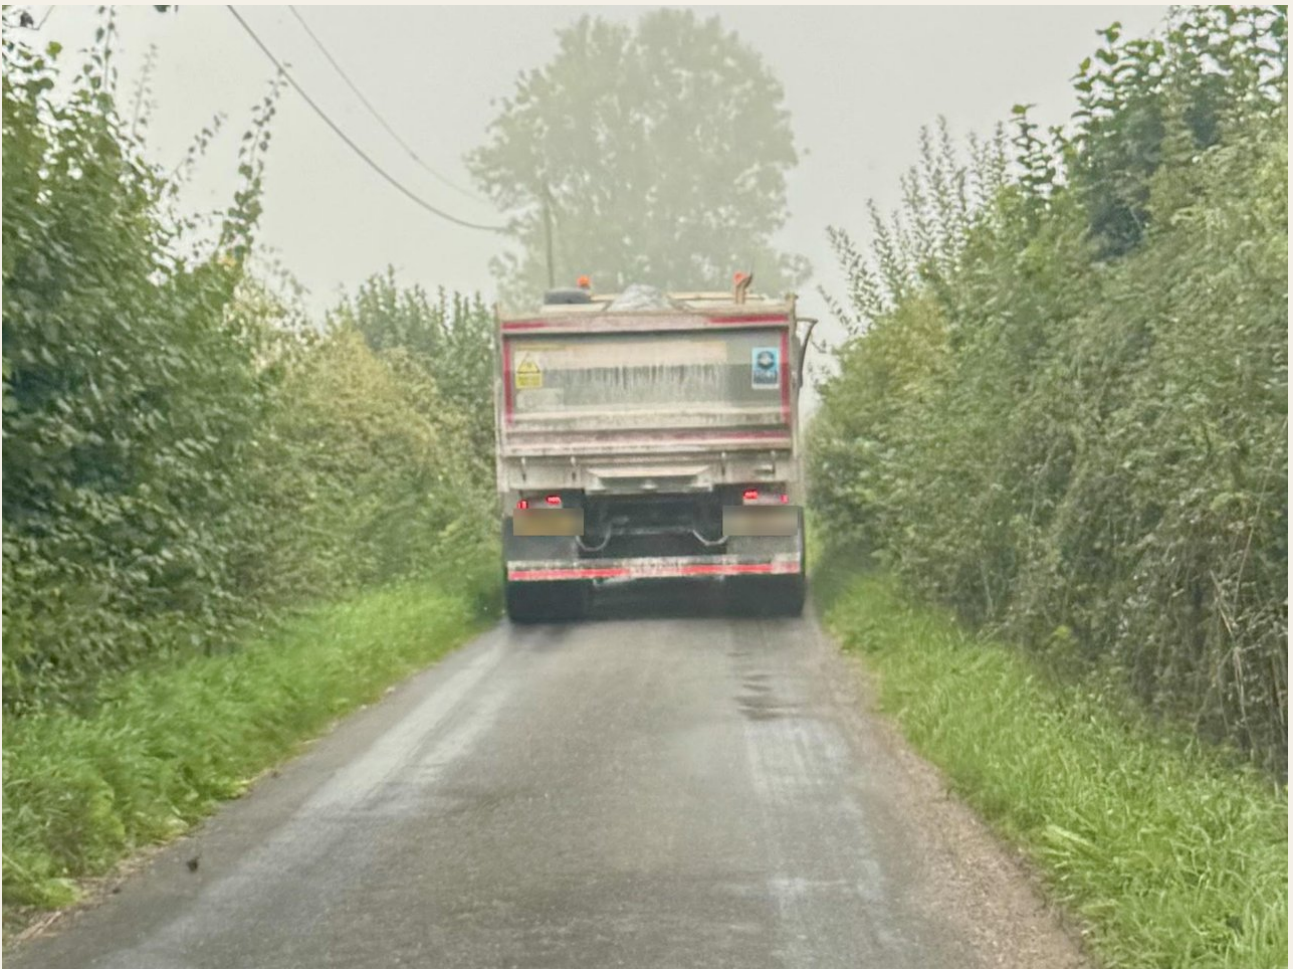
MILL LANE · 27 SEPTEMBER 2026

## A single lorry fills Mill Lane

Between Empshott Grange and the B3006, a tipper lorry fills Mill Lane from verge to verge.

One car can wait in a lay-by. Two vehicles meeting it can block the lane completely.

There is no room for vehicles to pass, and little or no refuge for walkers, cyclists or horse riders.

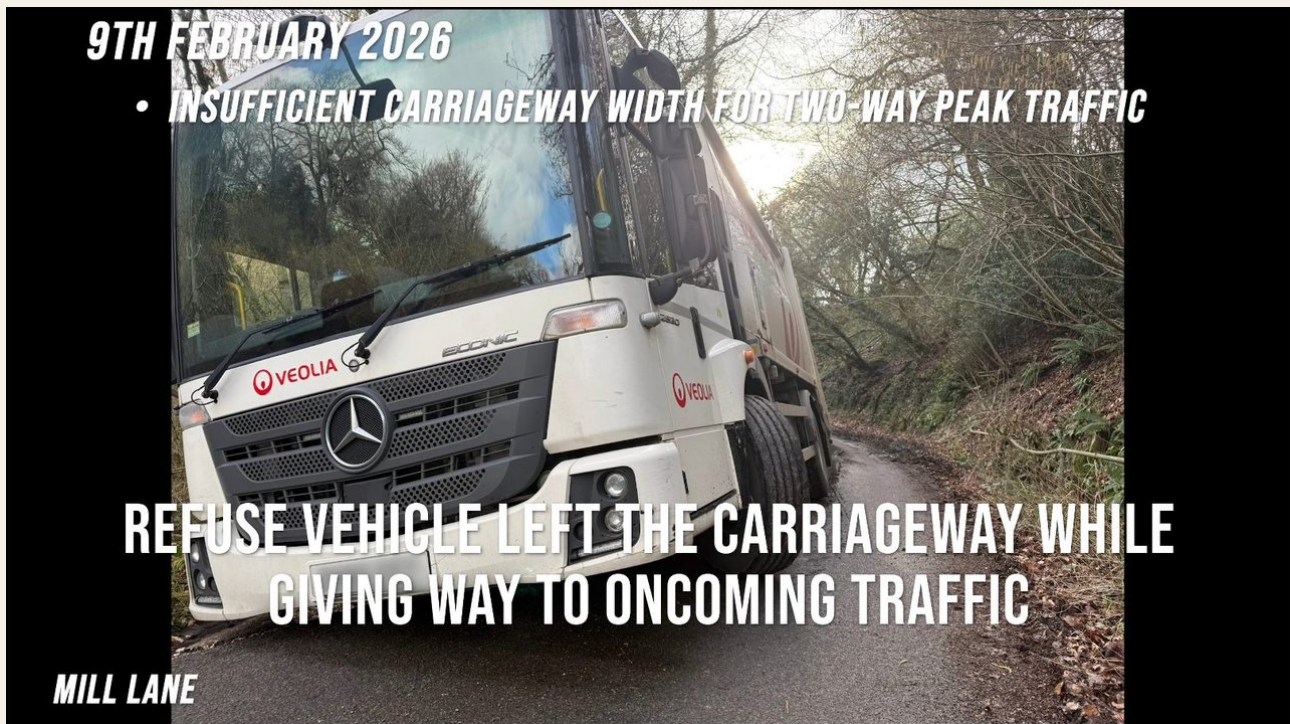
MILL LANE • 9 FEBRUARY 2026

## Mill Lane is too narrow for repeated commercial vehicle movements

On Mill Lane, around 200 metres south of Empshott Grange, a Veolia refuse vehicle — a routine scheduled service movement — was forced to leave the carriageway entirely to allow oncoming traffic to pass. Once off the carriageway, the vehicle could not simply continue its journey and took more than 24 hours to be moved.

This is not an unusual or exceptional vehicle. It demonstrates the practical difficulty of accommodating ordinary commercial traffic on a lane of this width. Refuse vehicles, delivery vehicles, service vans, maintenance vehicles and other larger vehicles cannot always pass opposing traffic within the carriageway and may have to stop, reverse, mount the verge or wait for another vehicle to clear.

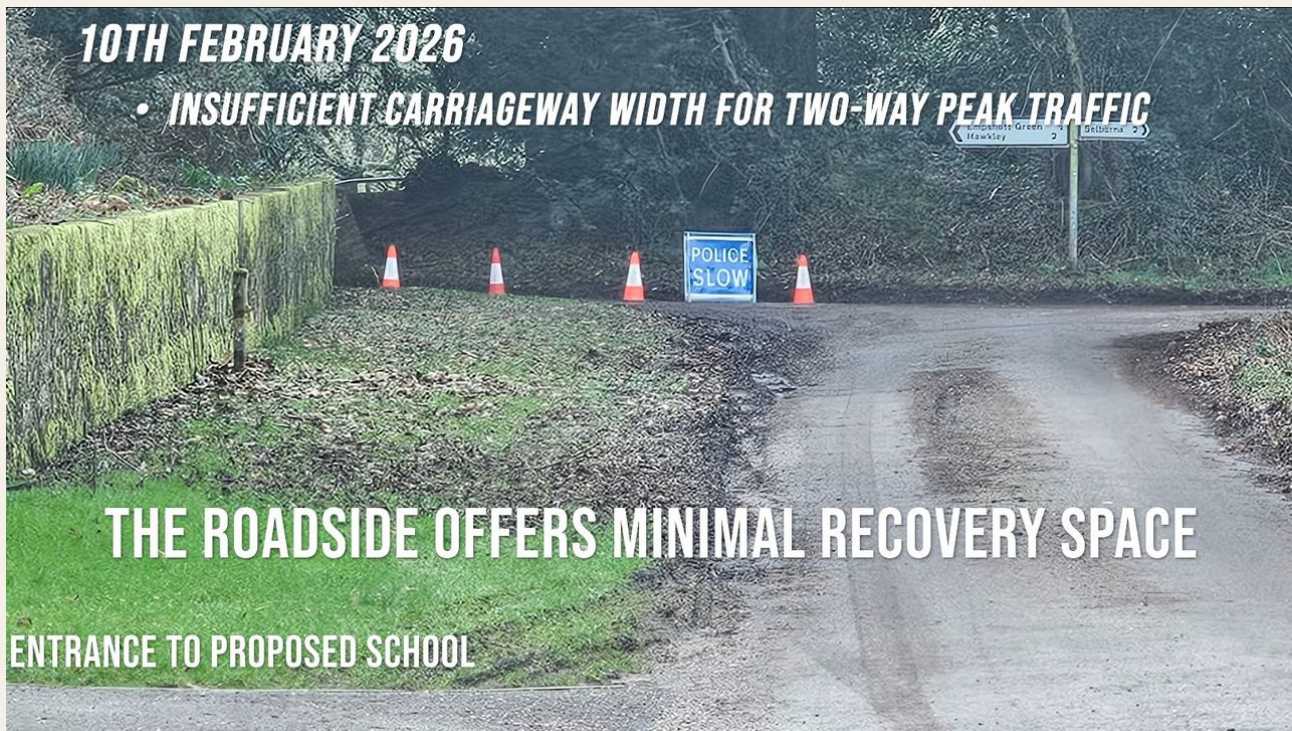
PROPOSED SCHOOL ENTRANCE • 10 FEBRUARY 2026

## When the road is blocked, there is nowhere to clear to

This is the junction that would serve the proposed school entrance. The carriageway here is bounded by hedge-bank and verge with little usable margin to either side: the roadside offers minimal recovery space, with almost nowhere to pull a stricken vehicle clear of the running lane. When the refuse vehicle seen in the previous exhibit had to be recovered, the operation took over 24 hours — police traffic management was needed at this very junction, and for that time the way past the proposed entrance was obstructed. An obstruction, breakdown or recovery at this point is not absorbed by the road; it closes it for as long as the vehicle remains.

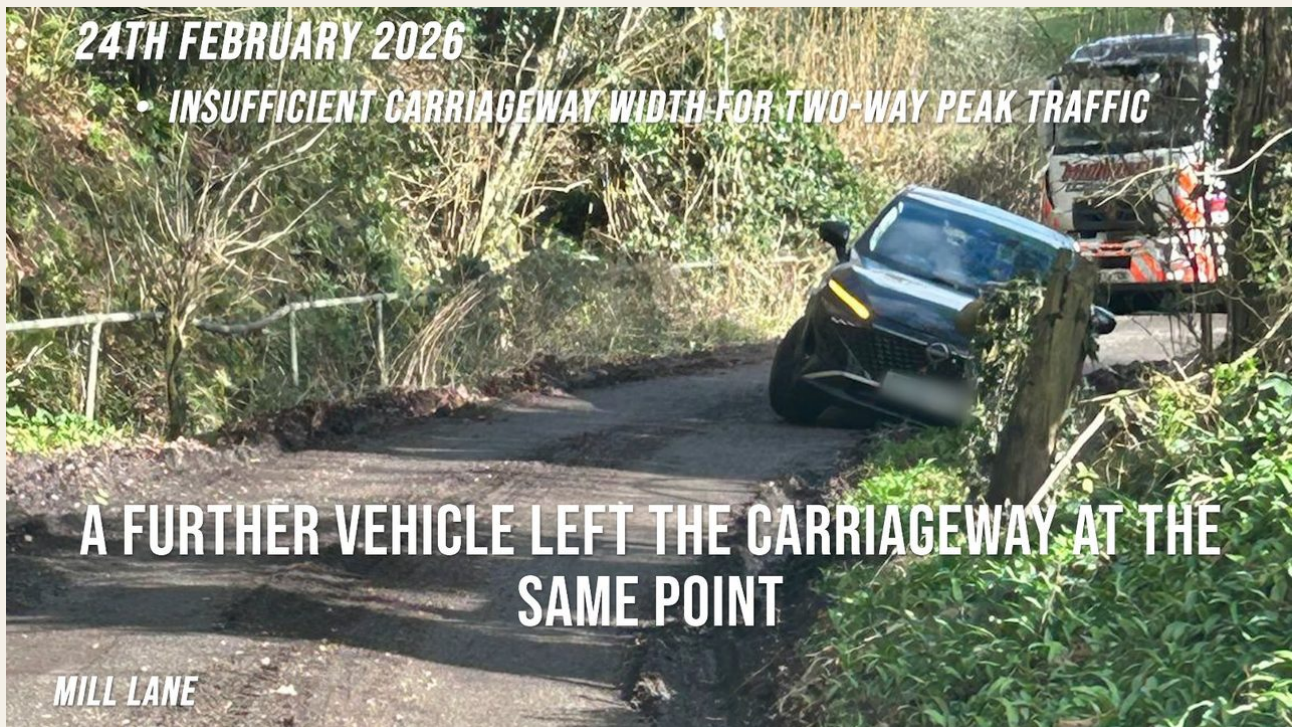
MILL LANE • 24 FEBRUARY 2026

## A further vehicle leaves the carriageway at the same point

On 24 February 2026 another vehicle left the carriageway at the same constrained point on Mill Lane, again requiring recovery (the recovery vehicle is visible behind). A spot where ordinary vehicles repeatedly run off the surface is not one that can safely absorb concentrated, time-pressured school traffic.

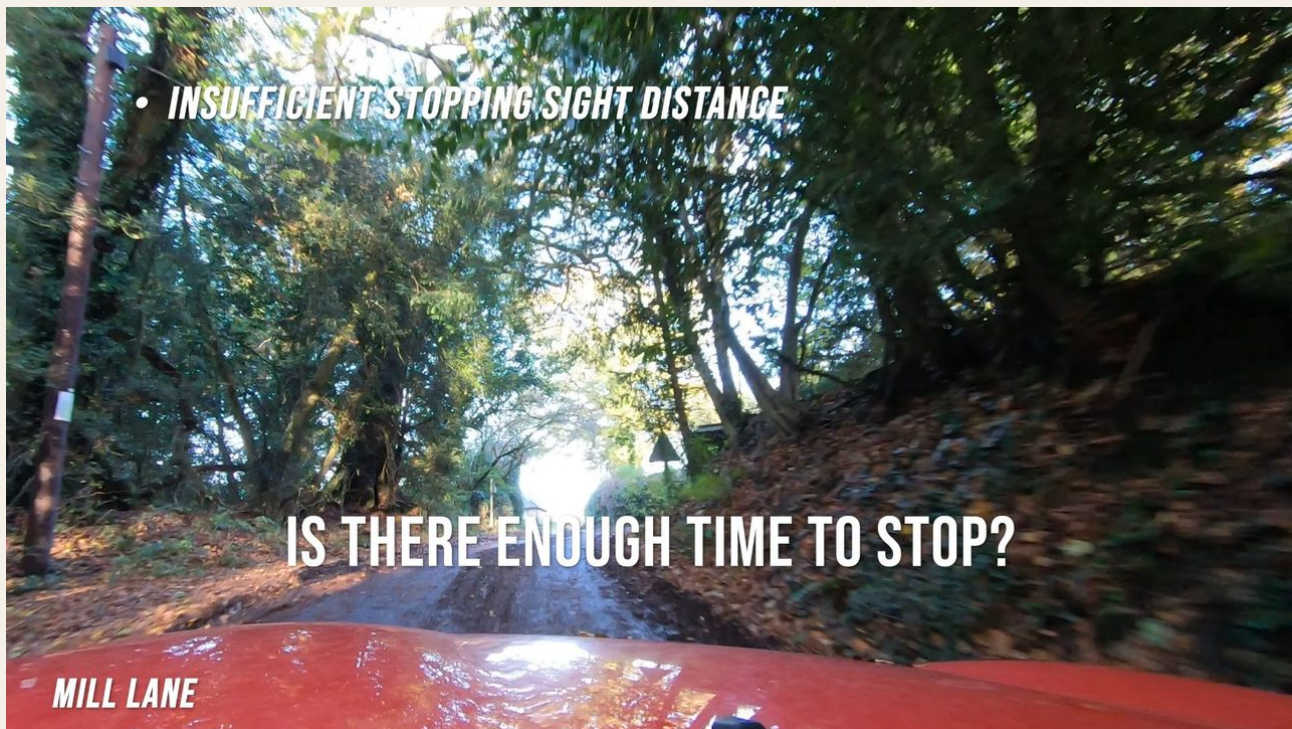
MILL LANE • STOPPING SIGHT DISTANCE

## Is there enough time to stop?

This is Mill Lane heading north towards the Church Lane junction — the point at which every vehicle leaving the proposed school would pull out. Along the approach, tree canopy, bends and gradient limit how far ahead a driver can see, and therefore how much time there is to stop. On a lane shared with walkers, riders and oncoming traffic, that margin is the difference between a near-miss and a collision — and it would be tested by concentrated school traffic at every drop-off and collection.

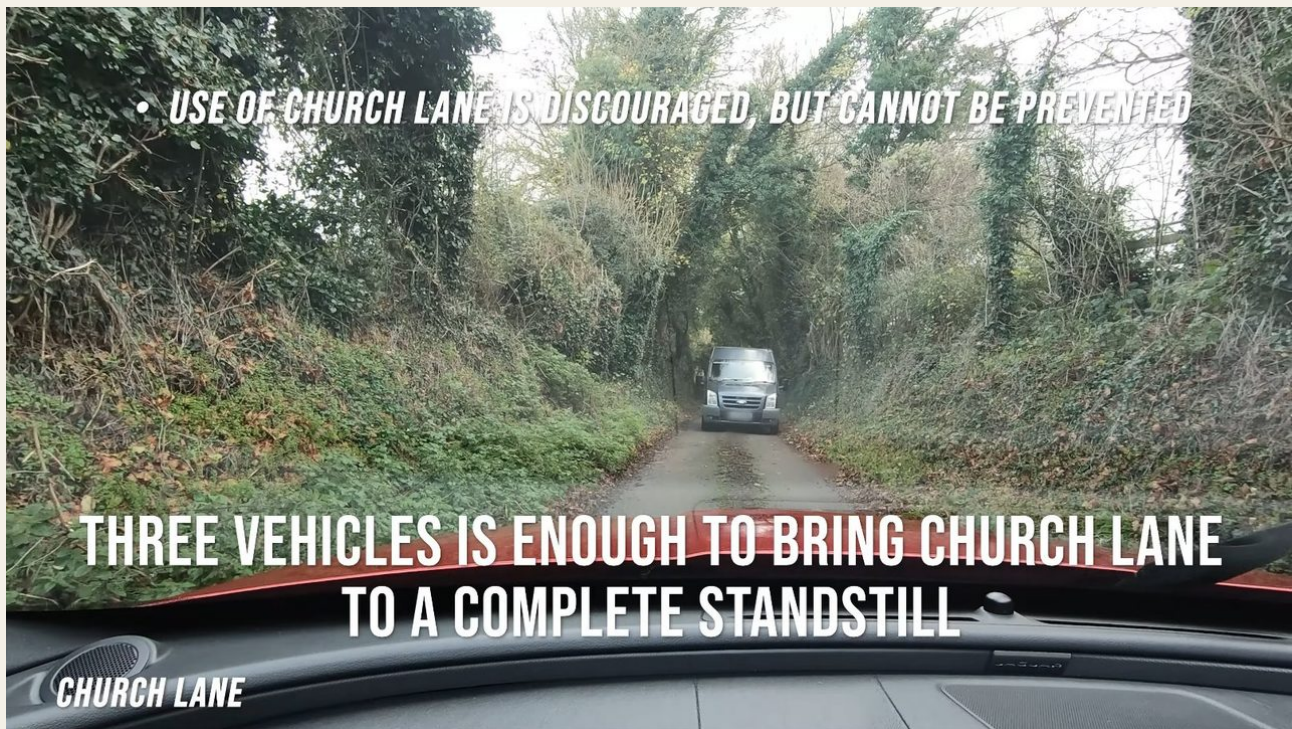
#### CHURCH LANE

### Three vehicles bring Church Lane to a standstill

Church Lane is narrower still. Its use is discouraged, but nothing prevents drivers from taking it — and it takes only three vehicles meeting to bring it to a complete standstill, with reversing the only way out. School traffic seeking to avoid the main junction would inevitably find its way here.
