# Is Empshott Grange a *safe* school location?

*An evidence-based review of traffic, carriageway geometry and network resilience on the B3006, Mill Lane and Church Lane.*

Proposed school development at  
Empshott Grange

Highway safety & network resilience

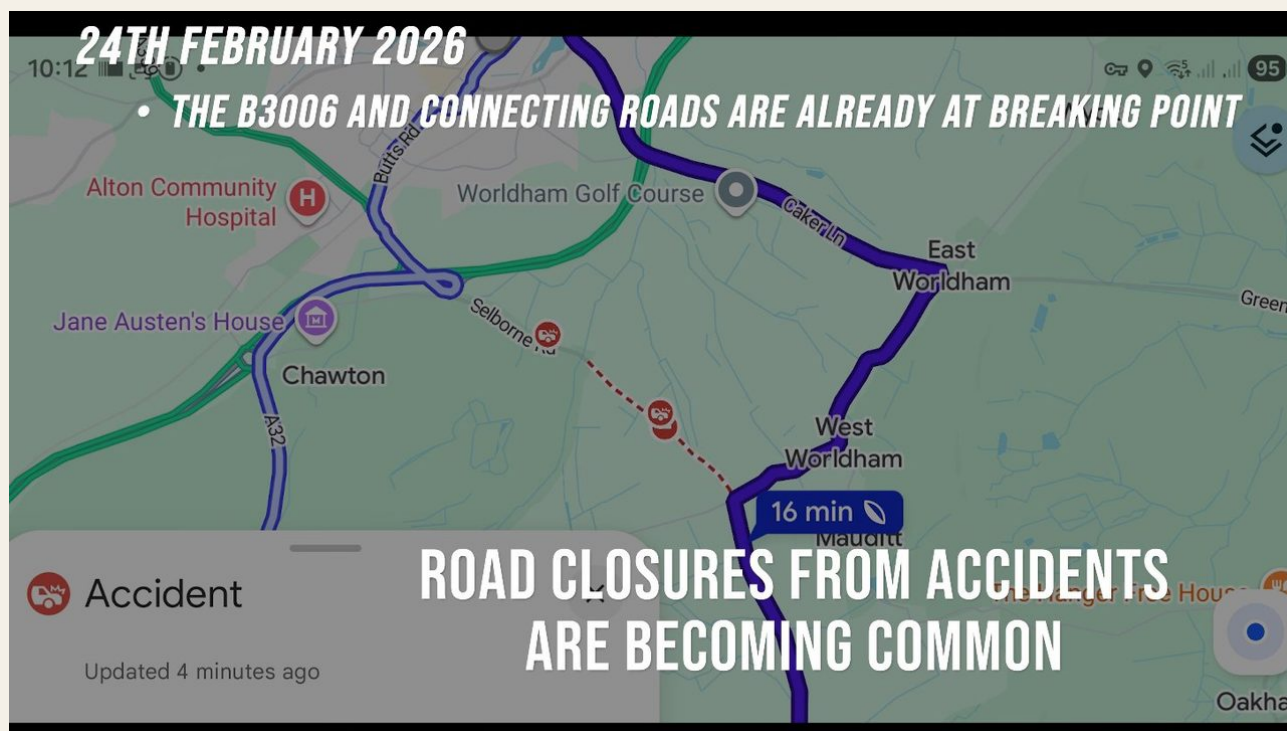
**B3006 & CONNECTING ROADS · FEBRUARY–MARCH 2026**

## A network already at breaking point

Road closures caused by collisions on the B3006 and its connecting roads are becoming a common occurrence. On 24 February 2026 an accident closed the route, diverting traffic onto a long detour through the surrounding villages — a network with so little resilience that one incident displaces traffic across the whole area.

The danger is not theoretical. The very next day, 25 February 2026, a vehicle left the carriageway on the B3006 Selborne Road and collided with a tree, leaving the driver seriously injured; East Hants Police issued a public appeal for witnesses and dashcam footage. This is the road as it already is — before a single school vehicle is added to it.
