# Is Empshott Grange a *safe* school location?

*An evidence-based review of traffic, carriageway geometry and network resilience on the B3006, Mill Lane and Church Lane.*

Proposed school development at Empshott Grange

Highway safety & network resilience

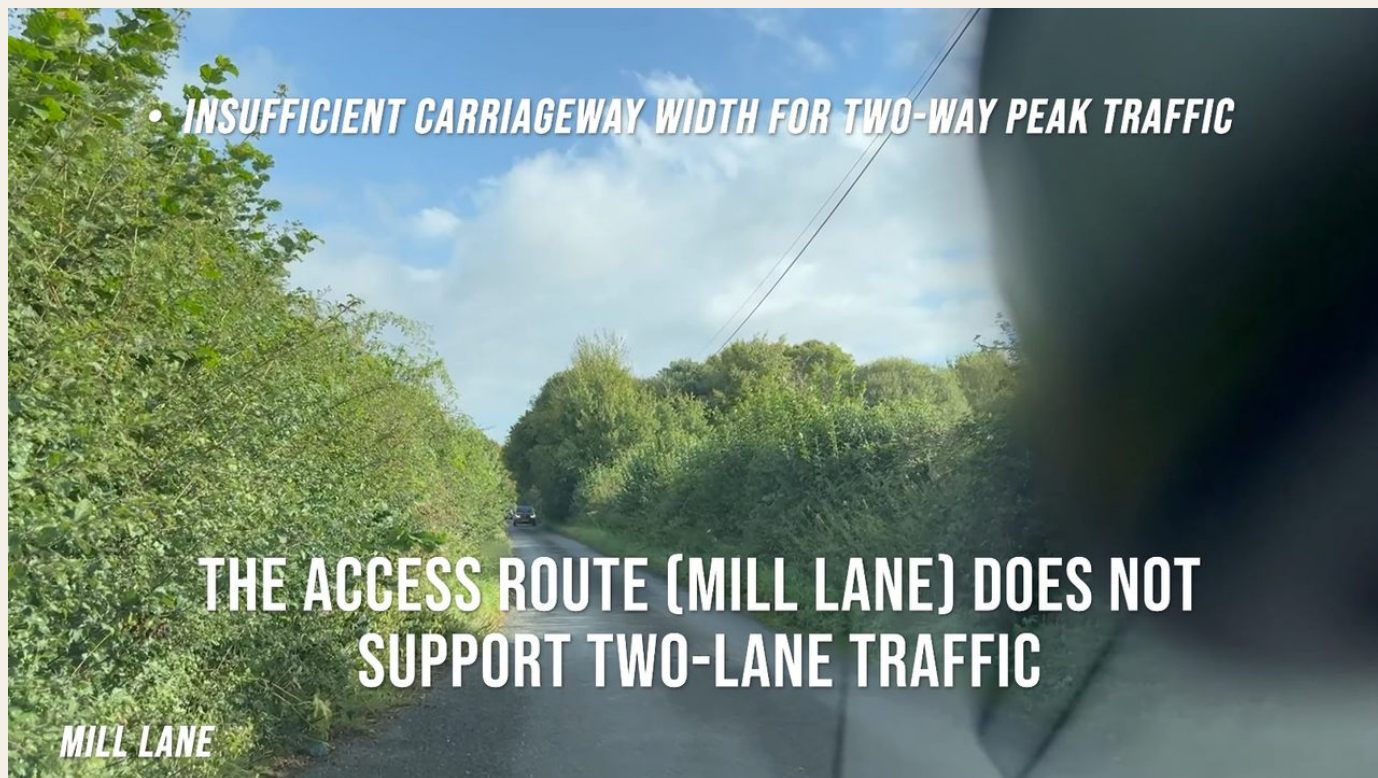
## MILL LANE · INSUFFICIENT CARRIAGEWAY WIDTH

The access route cannot carry two-way traffic

Mill Lane — the principal access route to the site — does not support two-lane traffic. A single-track lane, it has insufficient width for two vehicles to pass; where vehicles meet, one must yield to the verge or reverse to a wider point. The footage shows that even minor increases in traffic cause immediate congestion, and that multiple vehicles arriving simultaneously cause obstruction. Concentrated school-hour movements would force this repeatedly, at the busiest times of day.

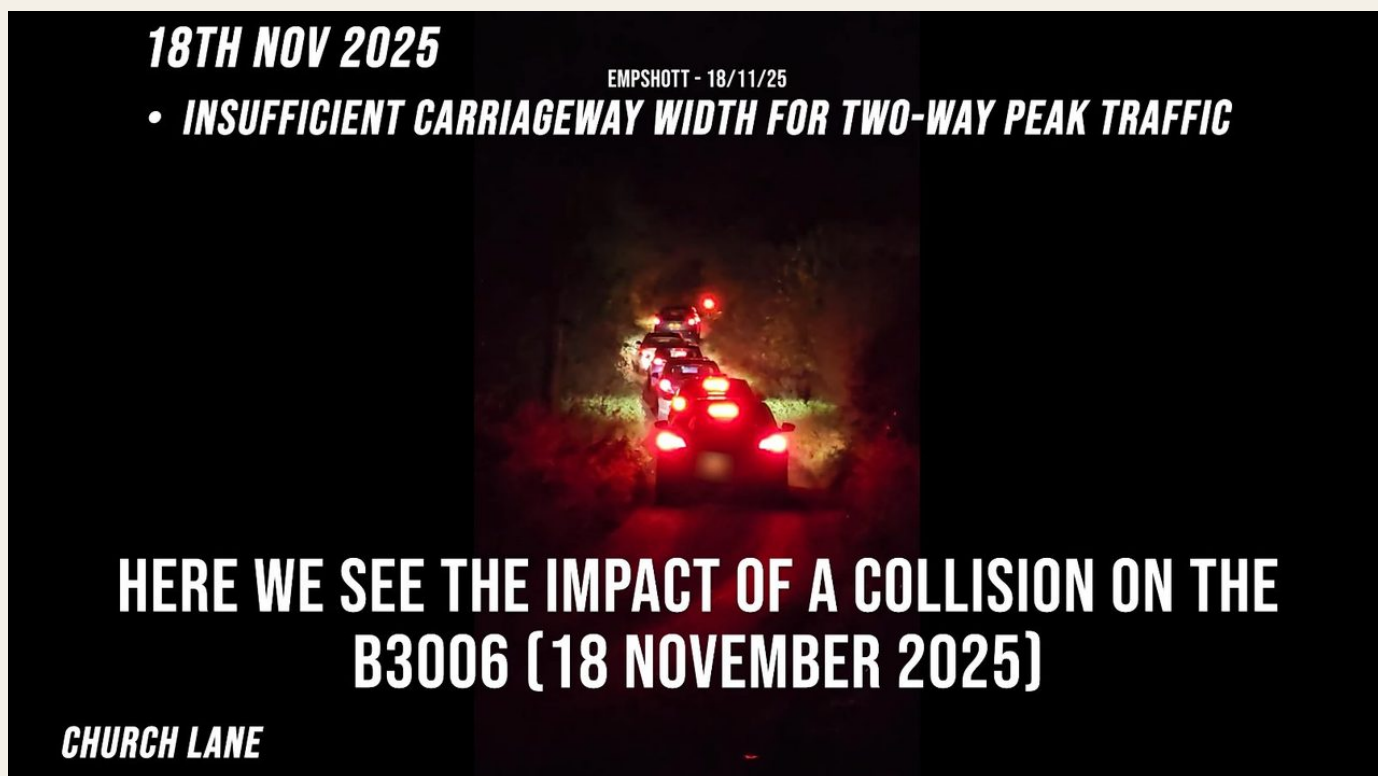
## A collision on the B3006 closes the network

On the evening of 18 November 2025, a collision on the B3006 caused queues to back up into the adjoining lanes, and traffic across Empshott — including Mill Lane and Church Lane — ground to a halt. With no viable alternative route, a single incident on the main road can render the surrounding network impassable.

In those conditions, access for emergency vehicles would be extremely difficult, if not impossible. During a similar incident, parents could be unable to reach the school, and children could be left effectively stranded until the road network clears.

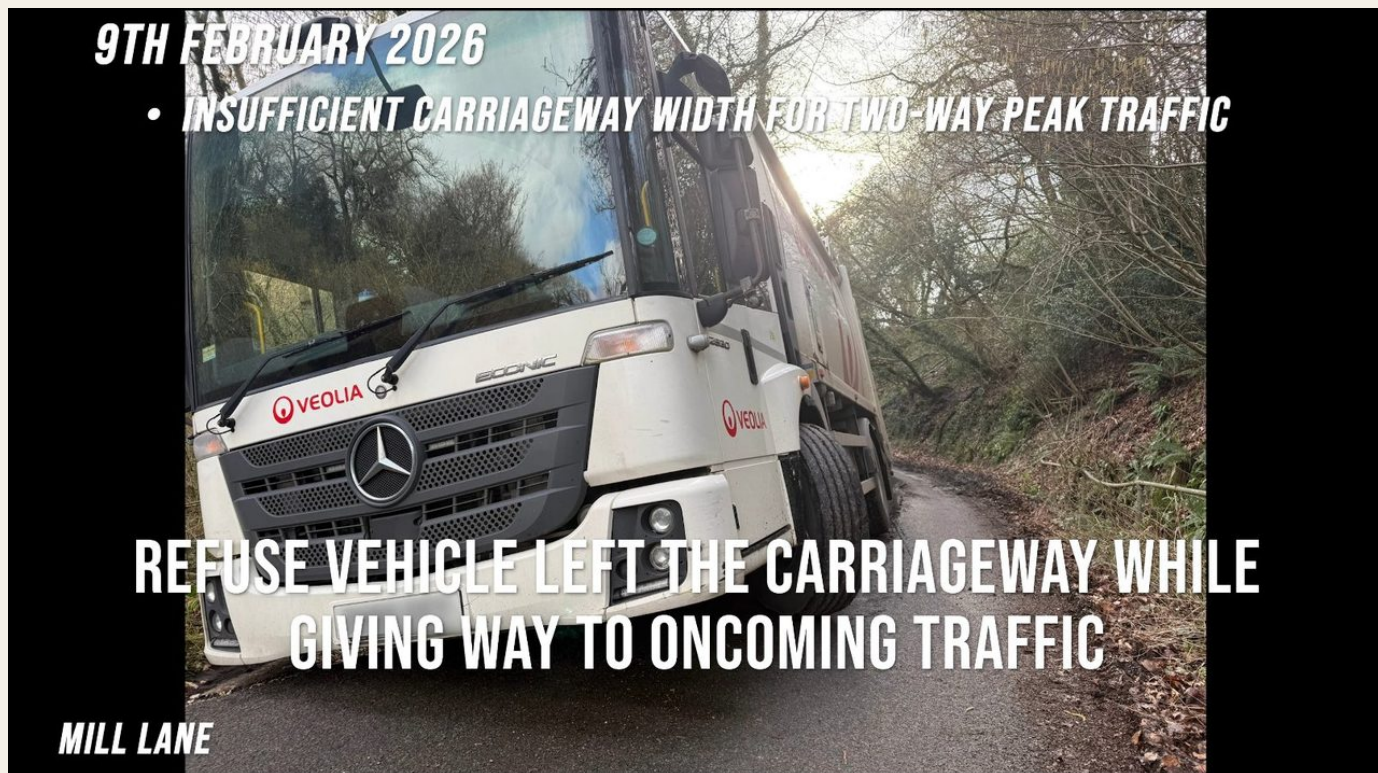
## Refuse vehicle forced off the carriageway

On Mill Lane, about 200 metres south of Empshott Grange, a Veolia refuse vehicle — a routine, scheduled service movement — was forced to leave the carriageway entirely to give way to oncoming traffic. It is a plain illustration of how unsuitable these lanes are for two-way traffic: when a larger vehicle meets oncoming traffic there is nowhere to pass, and one of them must mount the verge or reverse before either can move.

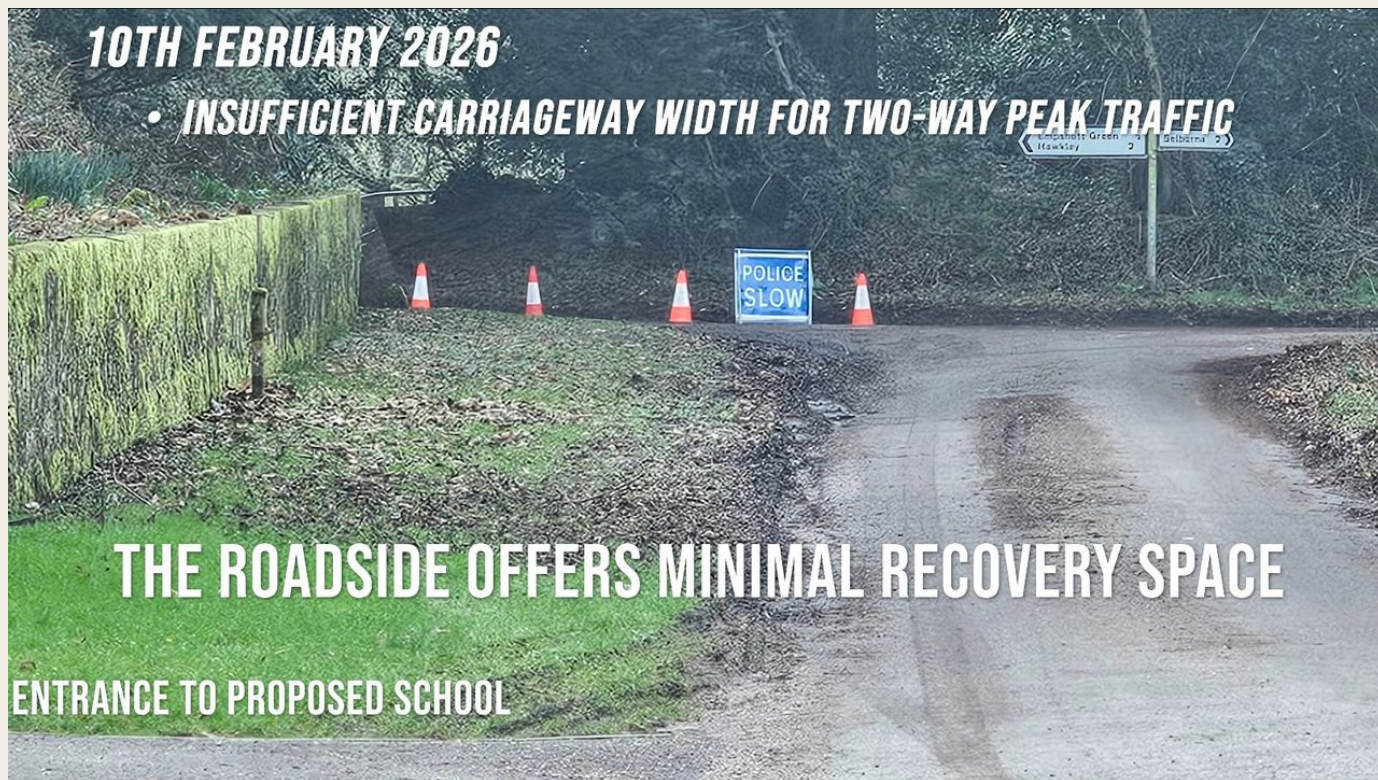
A single obstruction can block the lane entirely

This is the junction that would serve the proposed school entrance. The lane here is bounded by hedgerows and verges, leaving little usable margin on either side and very limited space for a vehicle to pull clear.

In the event of a breakdown, obstruction or recovery operation, access past this point would be extremely difficult. The refuse vehicle shown in the previous exhibit took over 24 hours to recover, during which police traffic management was required at this very junction.

This demonstrates that incidents at this location are not easily absorbed by the road network. A stranded or recovering vehicle can effectively block the lane for as long as it remains in place.

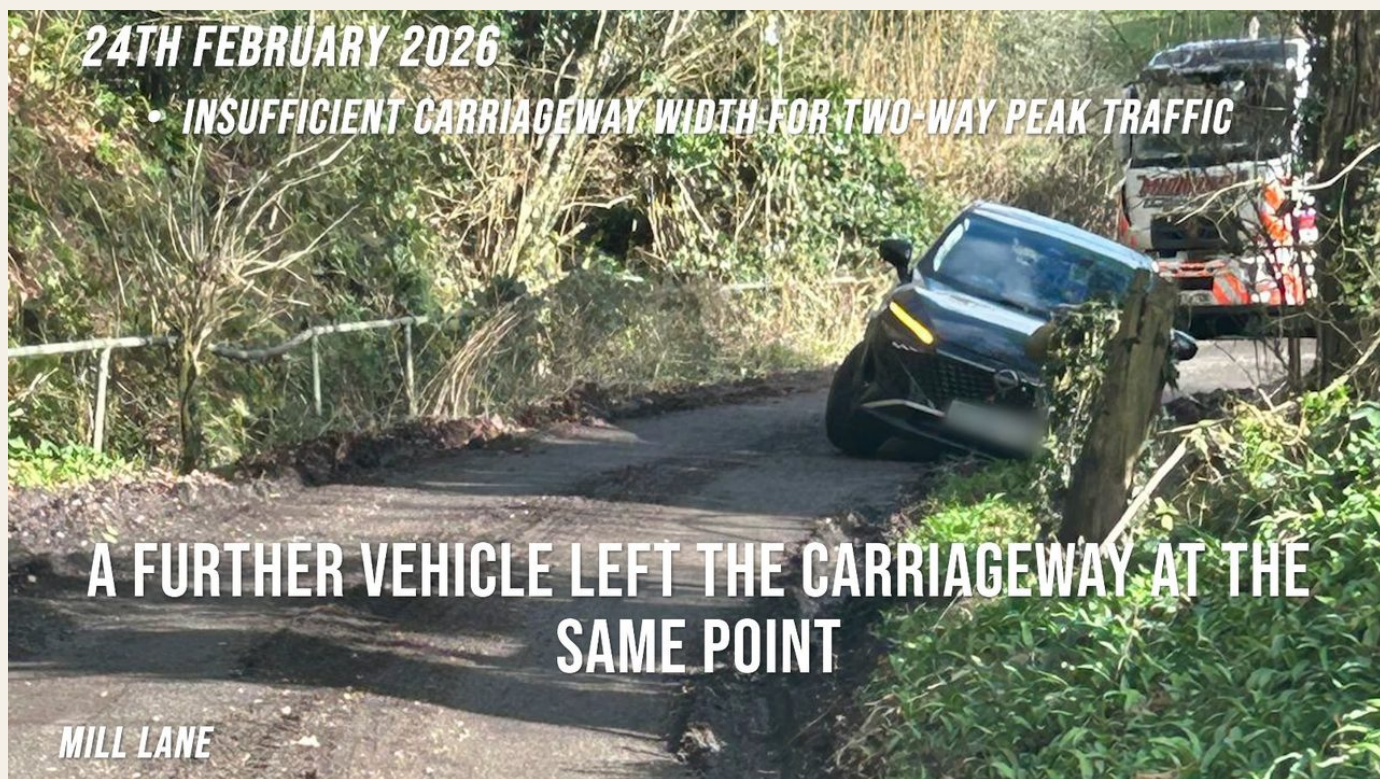
**MILL LANE · 24 FEBRUARY 2026**

A further vehicle leaves the carriageway at the same point

On 24 February 2026 another vehicle left the carriageway at the same constrained point on Mill Lane, again requiring recovery (the recovery vehicle is visible behind). A spot where ordinary vehicles repeatedly run off the carriageway is a measure of how little room these single-track lanes leave, even under today's traffic.

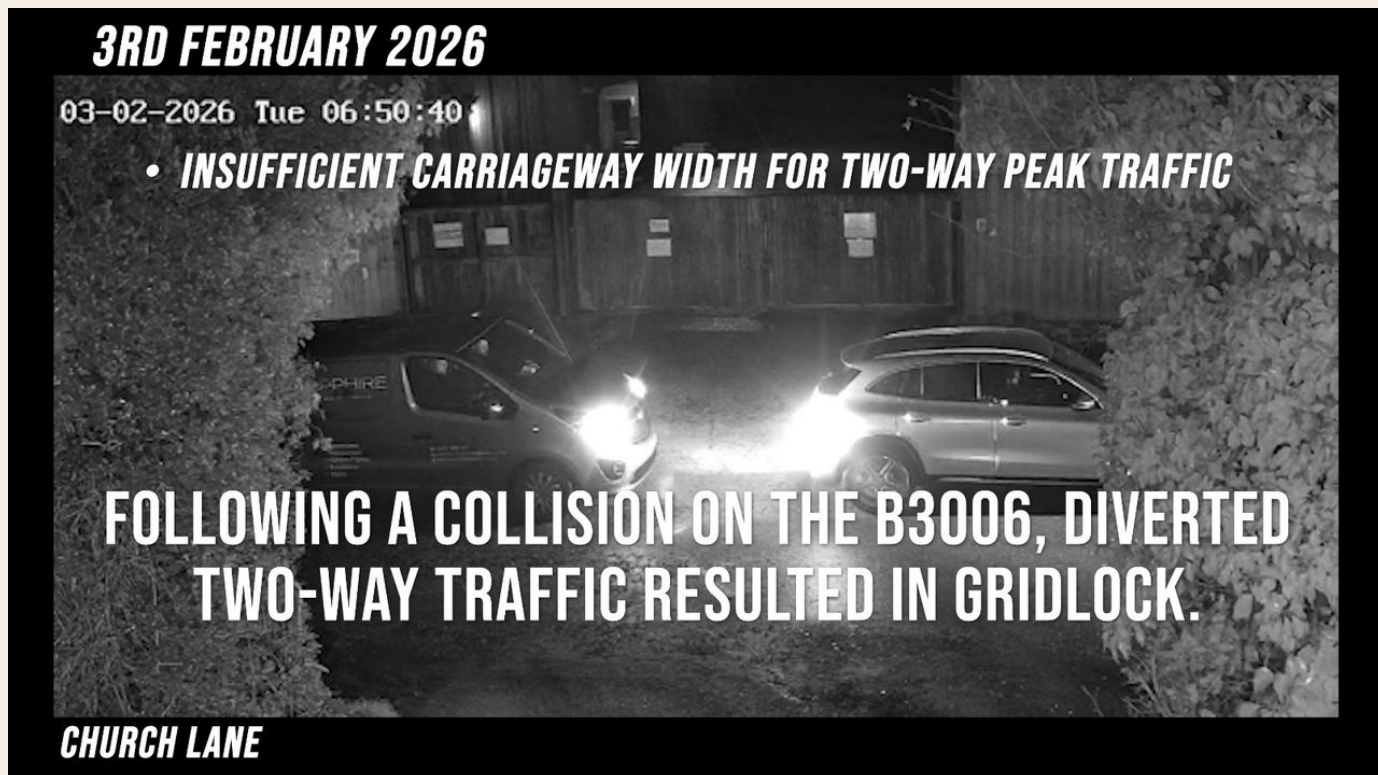
**CHURCH LANE · 3 FEBRUARY 2026**

## Diverted traffic gridlocks Church Lane

Following a collision on the B3006, traffic was diverted onto Church Lane — a lane that cannot accommodate two-way flow. Diverted traffic met head-on with nowhere to pass, resulting in gridlock, recorded here at 06:50.

When the main road fails, the village lanes inherit its traffic — traffic they were never designed to carry. In these conditions, access in and out of the village becomes extremely difficult, leaving residents, parents and emergency vehicles with no reliable route through.

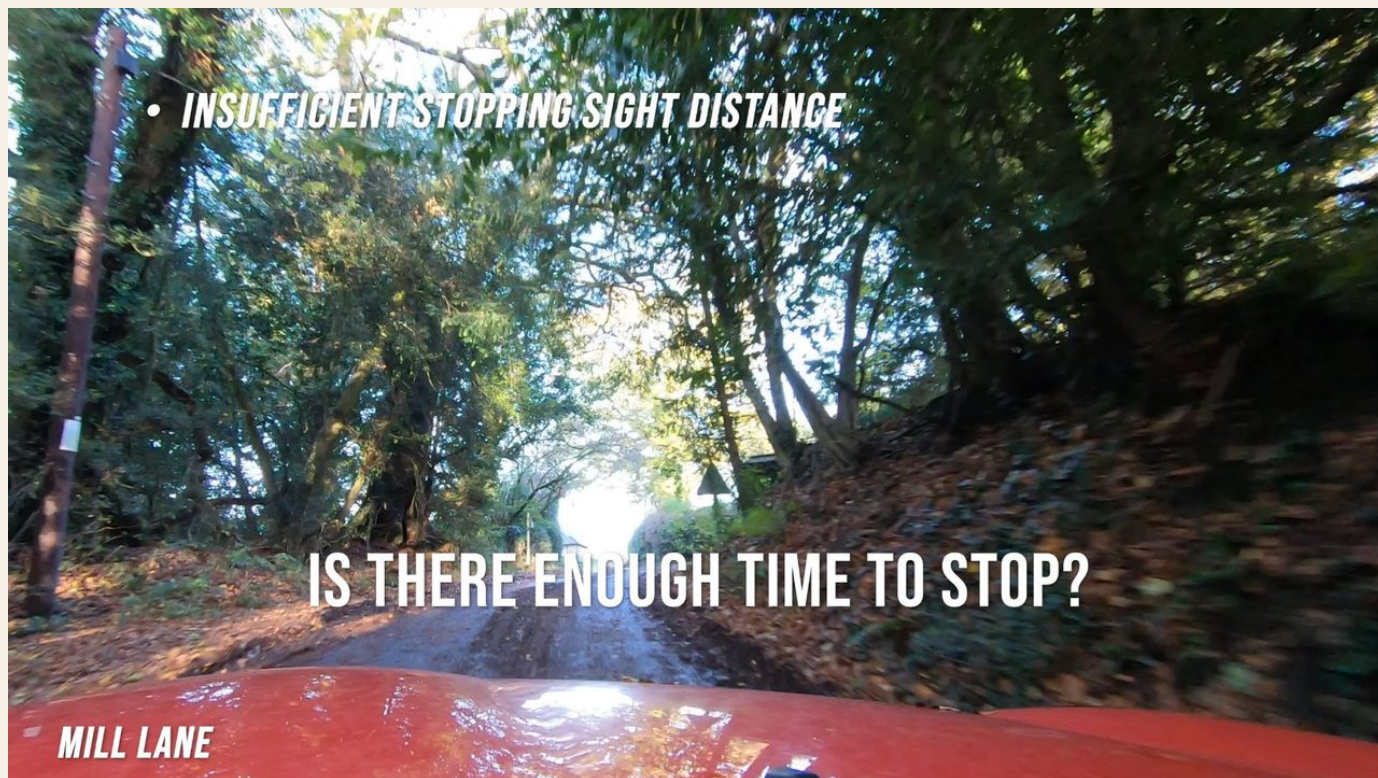
## MILL LANE · STOPPING SIGHT DISTANCE

Is there enough time to stop?

This is Mill Lane heading north towards the Church Lane junction. The tree canopy, bends and gradient sharply restrict forward visibility, reducing the time available for an approaching driver to see, react and stop.

The key issue is that every vehicle leaving the proposed school via Church Lane would have to pull out at this junction — yet an approaching driver cannot see the junction until they are within approximately 15 metres of it.

On a narrow lane shared with walkers, horse riders and cyclists, this is not a marginal concern. It is the difference between a near-miss and a collision, and it would be tested repeatedly at every school drop-off and collection period.

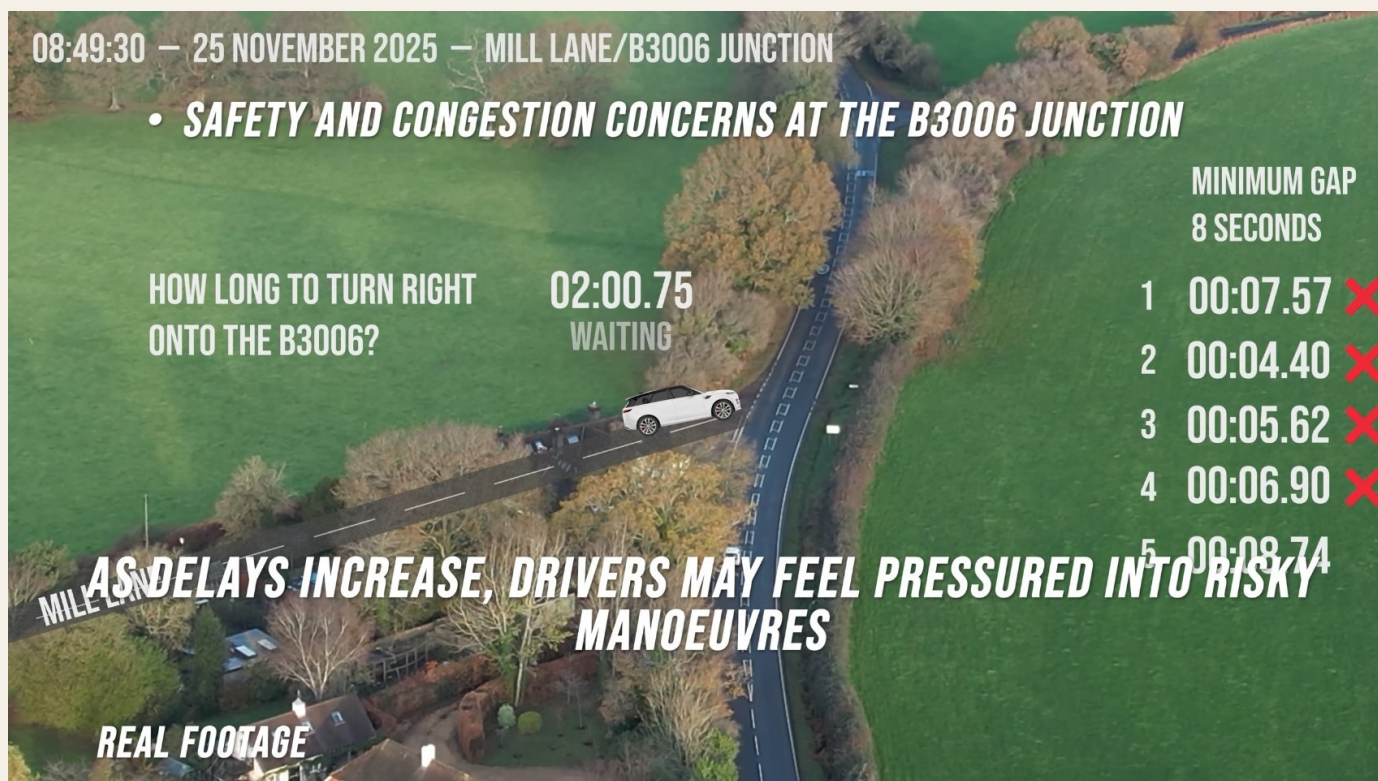
## Long waits to turn onto the B3006

Turning right out of Mill Lane onto the B3006 means waiting for a gap in fast-moving traffic. Using the real B3006 traffic footage, the overlay shows that a vehicle attempting to make this turn would have had to wait around two minutes before a safe opportunity arose — the on-screen timer reaching just over two minutes as one gap after another proves too short to pull out safely. At peak periods such delays are common, and with added school traffic, vehicles would be likely to queue back along Mill Lane. A vehicle trying to turn in from the B3006 could then be unable to enter — left waiting on the main road and obstructing traffic.

As delays build, drivers may be pressured into risky manoeuvres. A single vehicle waiting around two minutes for a safe gap can quickly create a compounding queue behind it, particularly during concentrated school drop-off and collection periods.

Hampshire County Council, as the highway authority, has recommended refusal of this application on highway-safety grounds — its substantive response of 11 February 2025, ref. SDNP/24/03736/FUL, maintained on 29 April 2025, identifies this Mill Lane/B3006 junction specifically, warning that the additional vehicle movements could cause unsafe queueing back onto the B3006 and shunt-type collisions that could not be adequately mitigated. Concentrated school-hour demand would only intensify that risk.

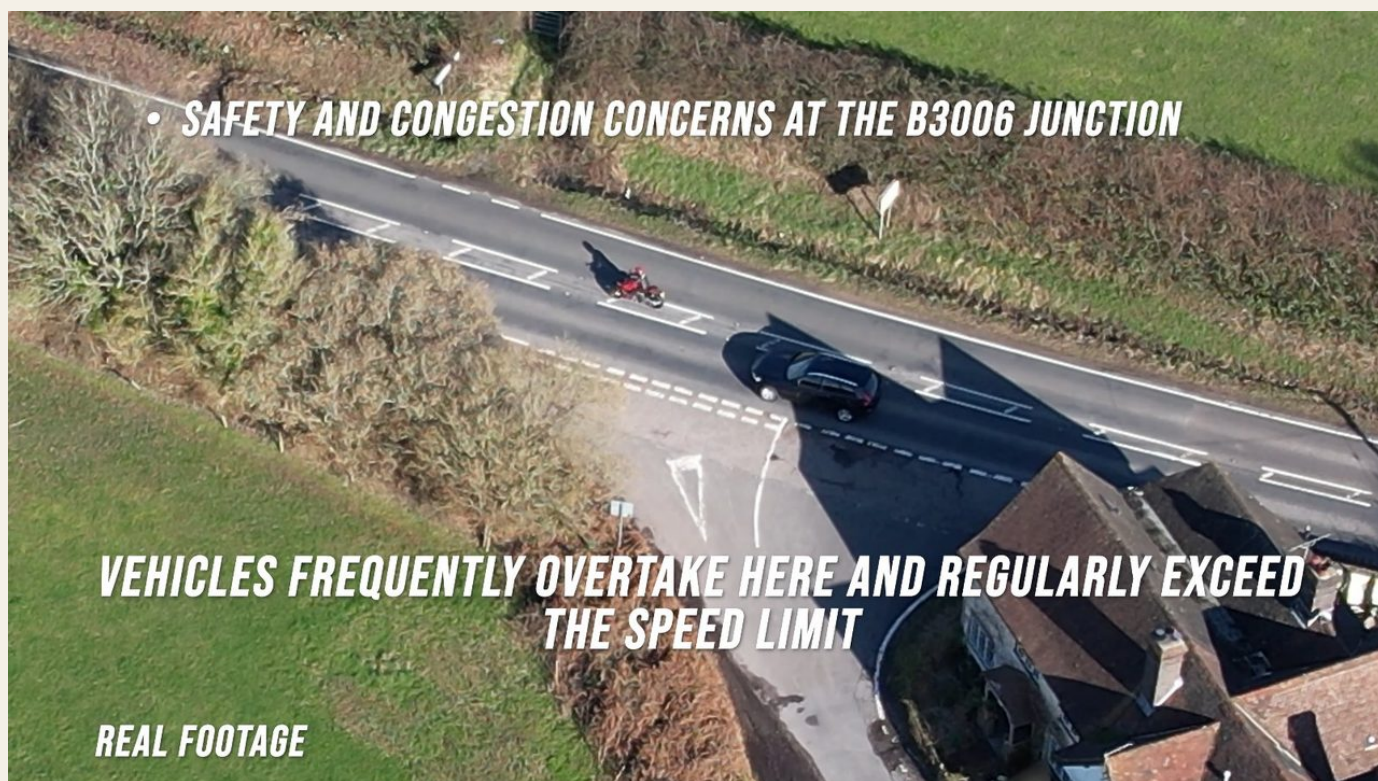
## Overtaking and excess speed at the junction

On the B3006 approach to the Mill Lane junction, vehicles frequently overtake and regularly exceed the speed limit. Traffic is often accelerating hard in anticipation of the 60mph national speed limit beyond the junction, meaning vehicles are gathering speed at exactly the point where traffic from Mill Lane must turn out.

This is already a demonstrably hazardous location. There have been two accidents at or near this junction in recent years, including one serious incident. Introducing regular school-related turning movements — including parents unfamiliar with the road and slow-moving minibuses — would create repeated points of conflict with fast-moving through-traffic.

Given the existing accident history, observed overtaking, excess speed and limited safe gaps, the risk is not theoretical.

Additional peak-time turning movements would materially increase the likelihood of a serious collision at a junction that is already unsafe.

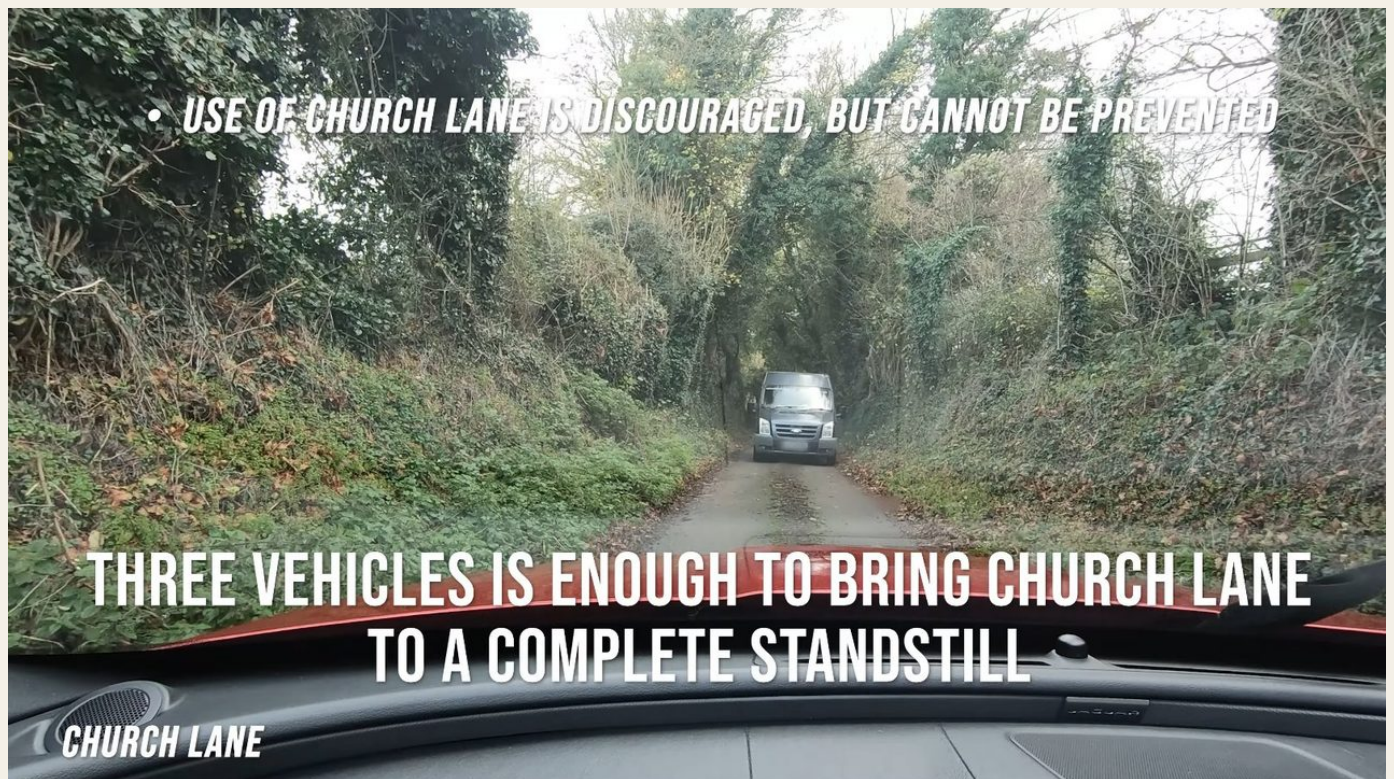
## CHURCH LANE

# Three vehicles bring Church Lane to a standstill

Church Lane is narrower still. Although its use is discouraged, nothing physically prevents drivers from taking it — and satnavs routinely direct traffic down this route. It takes only three vehicles meeting to bring the lane to a complete standstill, with reversing the only way out.

School traffic seeking to avoid delays at the main Mill Lane/B3006 junction would inevitably find its way onto Church Lane, increasing the risk of blockages on a lane that is already unsuitable for two-way traffic.

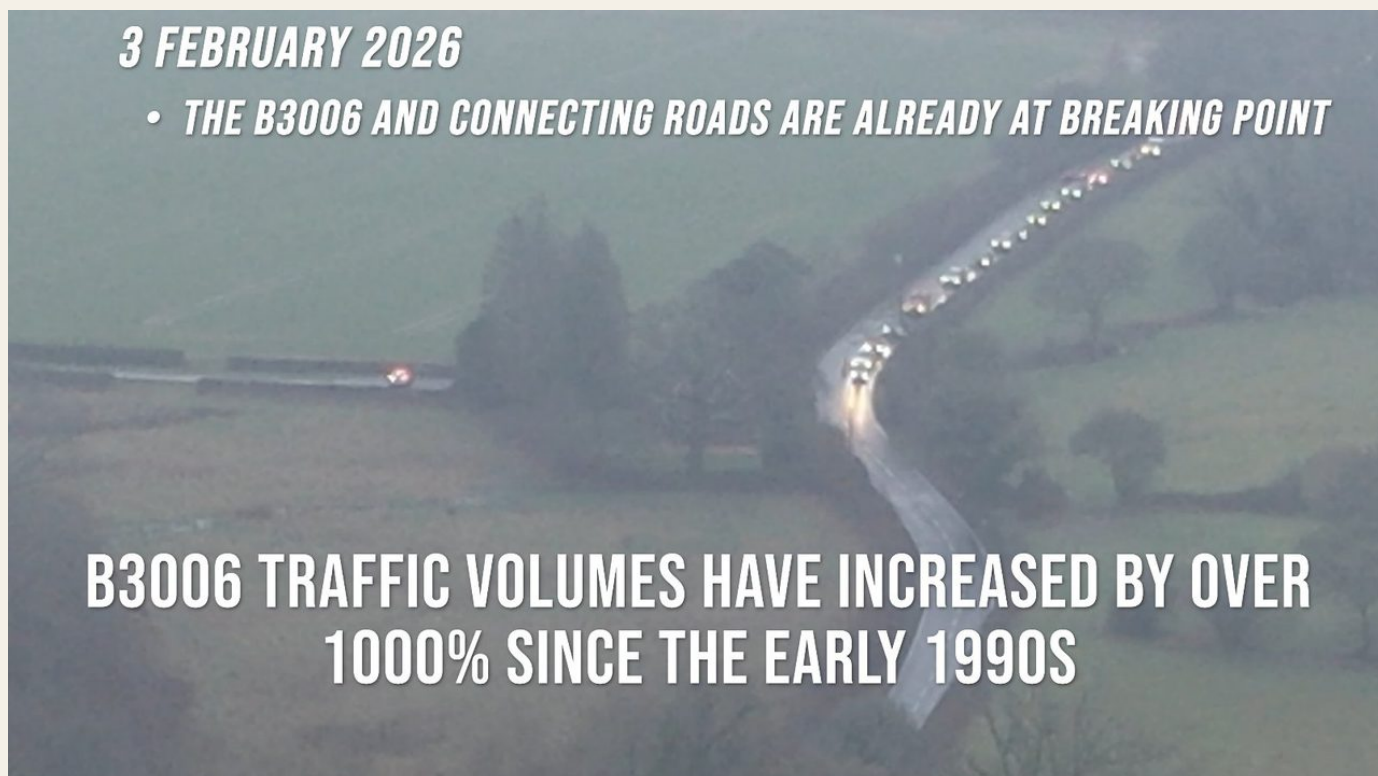
## A road already carrying far more than it was built for

The B3006 is a rural B-road now carrying heavy commuter flows. Traffic has risen by more than 1,000% since the early 1990s, taking it far beyond the level it was designed to accommodate.

With significant housing growth being promoted across East Hampshire and the wider A31 corridor, and with no planned bypass or meaningful alternative route, these pressures are likely to worsen over time. Queues, delays, accidents and road blockages will place increasing strain on both the B3006 and the surrounding village lanes that are forced to absorb its traffic when it fails.

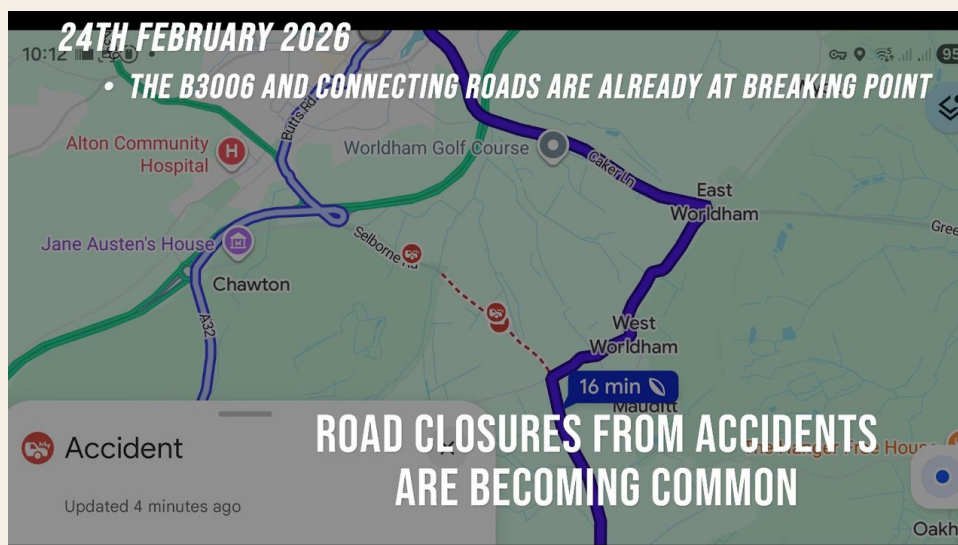
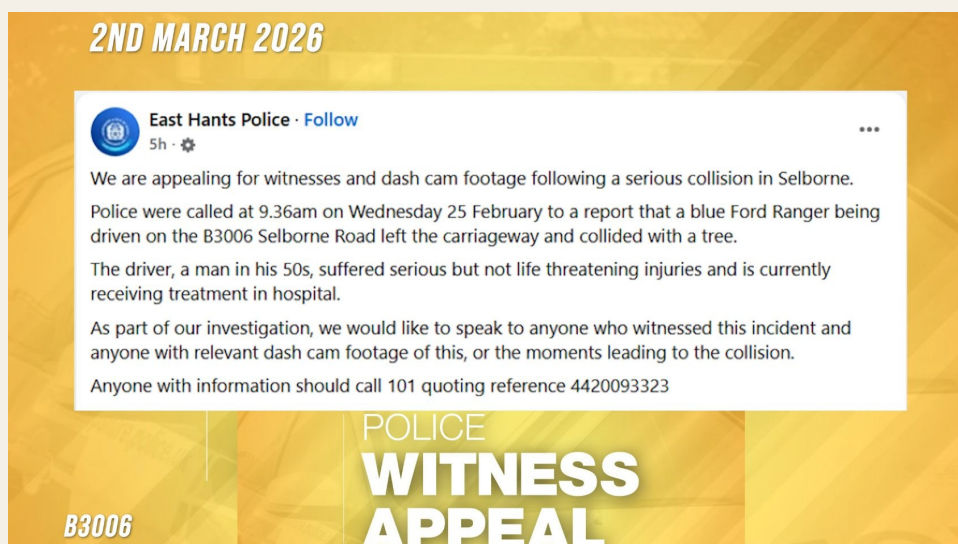
## A network already at breaking point

Road closures caused by collisions on the B3006 and its connecting roads are becoming a common occurrence. The accident on 24 February 2026 closed the route completely. Traffic was obliged to crawl through the surrounding villages in an attempt to escape. The school would add little to the B3006's own volumes; the concern is the reverse — that it would place pupils, staff and parents on this already-dangerous road every single day.

The danger is not theoretical. The very next day, 25 February 2026, a vehicle left the carriageway on the B3006 Selborne Road and collided with a tree, leaving the driver seriously

injured; East Hants Police issued a public appeal for witnesses and dashcam footage. This is the road as it already is — and the road that every pupil, parent and member of staff would have to travel, every day.

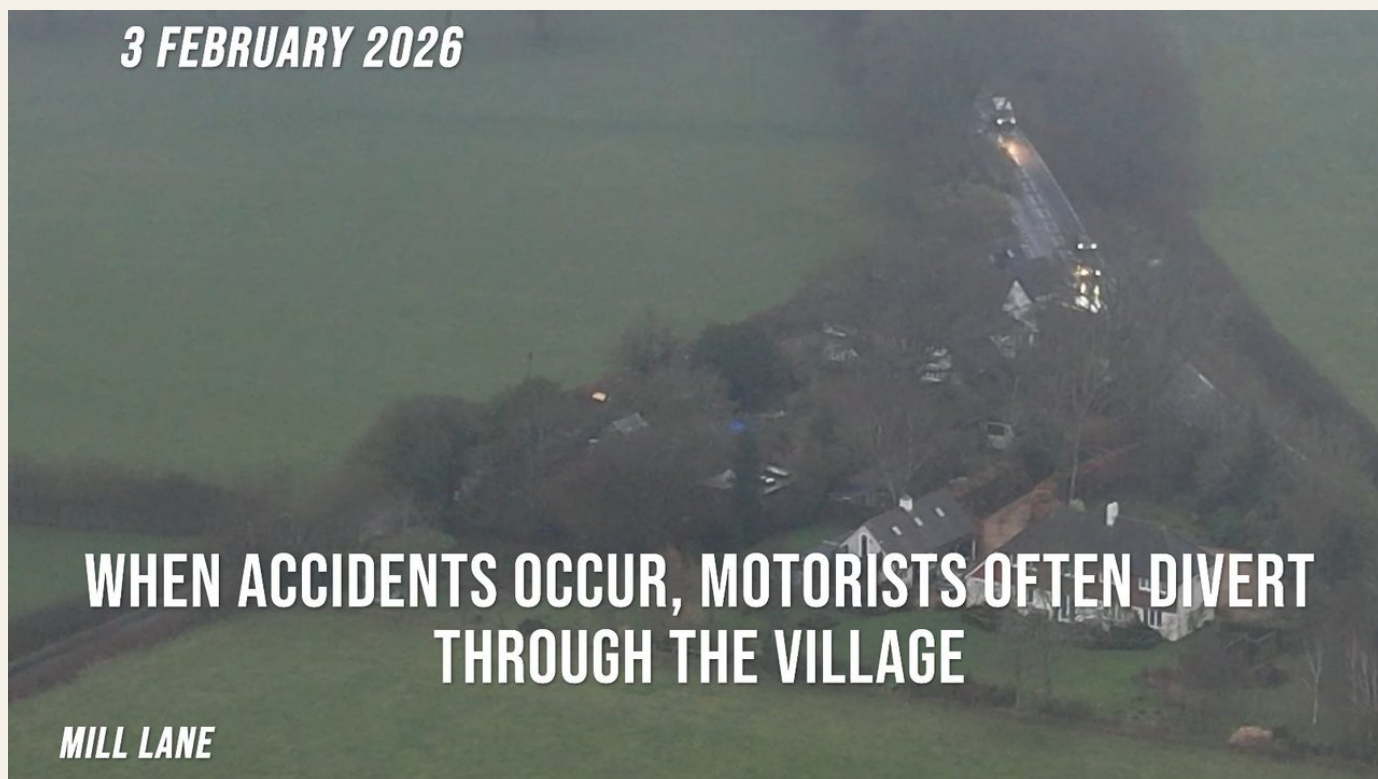
## Incidents push diverted traffic through the village

When accidents occur on the B3006, motorists often divert through the village along Mill Lane and the connecting lanes — routes with no pavements, shared with residents, walkers, horse riders and cyclists. Past incidents already show how quickly that extra traffic overwhelms the village network. The concern is that a school would make the exceptional routine: more traffic, and the incidents that come with it, would mean more frequent diversions — until the congestion seen today only during an incident becomes a daily, peak-time condition, with vulnerable road users exposed each time.

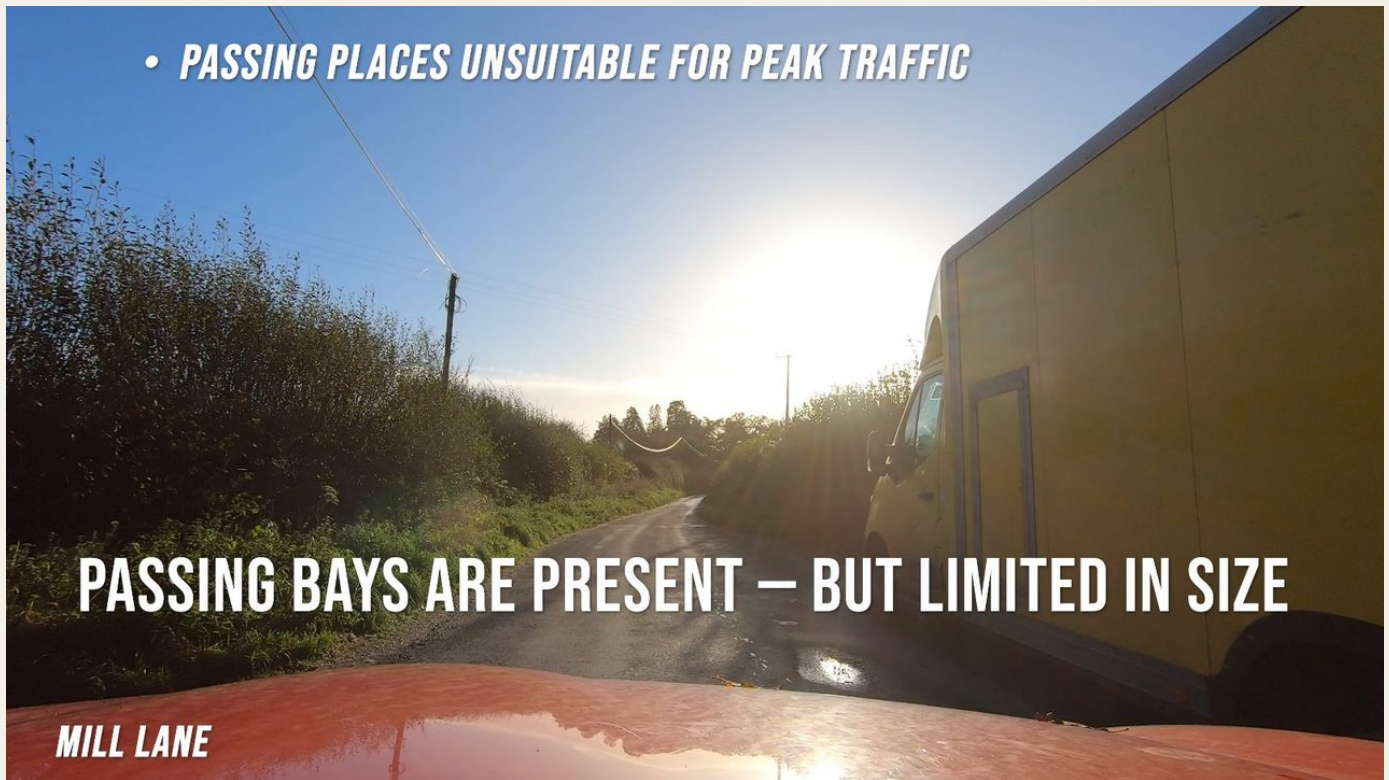
## MILL LANE

Limited passing bays, unsuitable for peak flow

Mill Lane does have some passing bays, but they are limited in number and small in size. They may be sufficient for occasional vehicle meetings, but they are not suitable for the repeated two-way movements that would occur during school drop-off and collection periods.

Their usefulness also depends on them being kept clear. Where passing bays are used for parking, even temporarily, they cease to function as passing places altogether.

During concentrated school traffic, several vehicles could meet in quick succession on a narrow section of lane, causing traffic to stop, reverse, or wait until the obstruction clears. Rather than supporting steady two-way flow, the existing passing bays demonstrate how limited the lane's capacity really is.

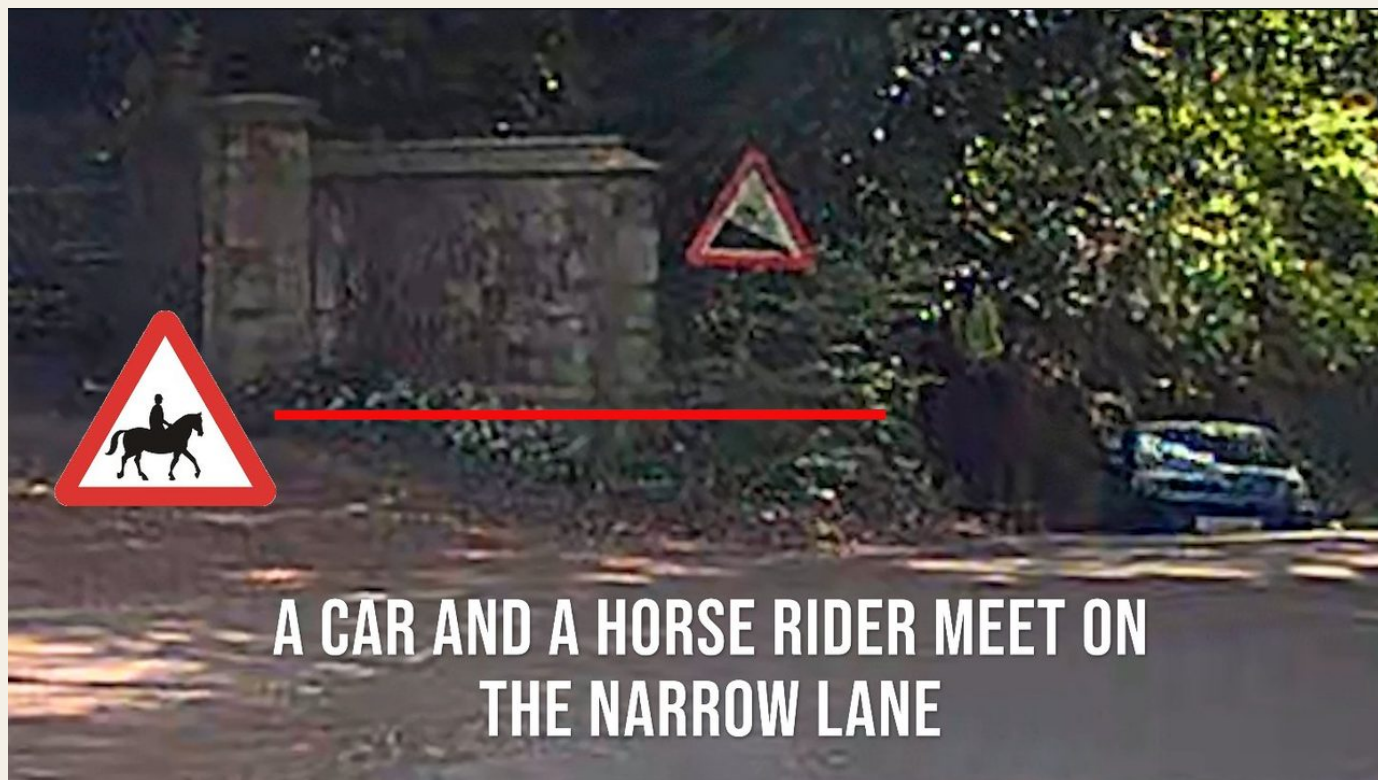
## No room when a car meets a horse

Mill Lane and Church Lane are established routes for horse riders, walkers and cyclists. When a car meets a horse on these lanes, there is no room to pass at a safe distance. The driver must stop and wait, while the rider has little or no refuge beyond the verge or hedge.

The footage records exactly this type of encounter, at the entrance to Empshott Grange. Under the school proposal, this would become the single access point for all arriving traffic — every minibus, taxi and car turning in from the lane during concentrated drop-off and collection periods.

This risk is not theoretical. Several years ago, in the same local network of narrow lanes, a collision involving a van and a horse resulted in the horse suffering catastrophic injuries and being put down at the roadside. That incident illustrates the severity of the consequences when vehicles and horses are forced into conflict on lanes with no safe passing space.
